2008 Physical Needs Assessment and Energy Audit For Federally Assisted Projects

Kuhio Homes

HPHA Project Number HIOP001007

Honolulu Oahu

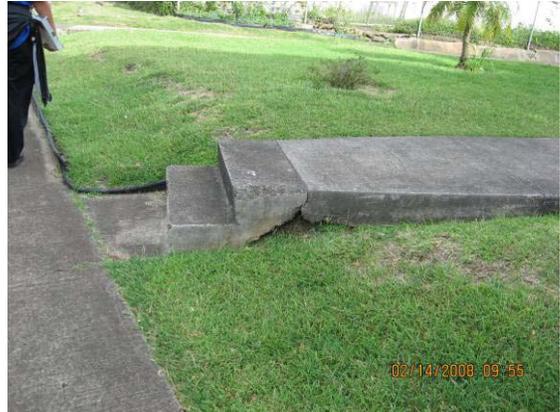
Photo 1: 533

Site Item Name: Steps
Deficiency: dangerous walks/steps
Remedy: Repair
Description: photo 657 (too narrow)

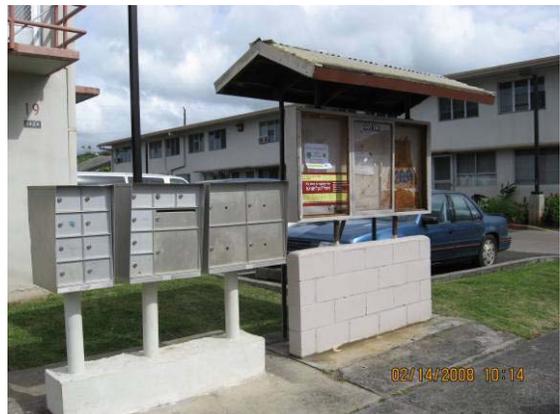
Photo 1: 604

Site Item Name: Mailboxes
Deficiency: damaged
Remedy: Repair
Description: & replace

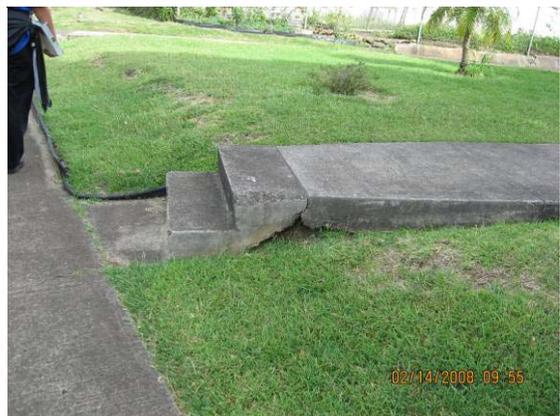
Photo 1: 533

Site Item Name: Walkways
Deficiency: cracked/gaps
Remedy: Repair
Description: ac paving - replace
conc walkway - crack &
upheaving

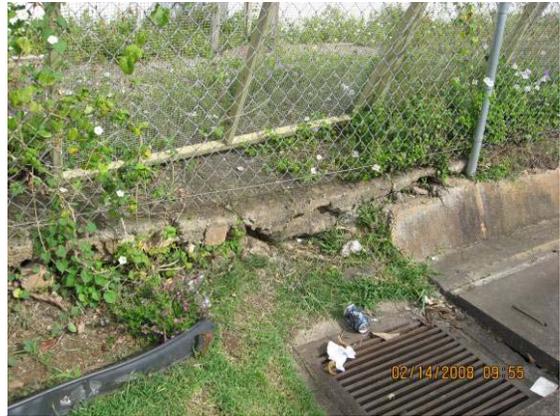
Photo 1: 537

Site Item Name: Fencing
Deficiency: damaged
Remedy: Replace
Description: & missing

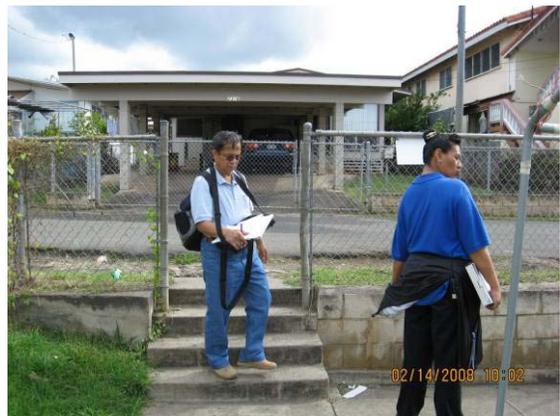
Photo 1: 562

Site Item Name: Gates
Deficiency: missing
Remedy: Install
Description:

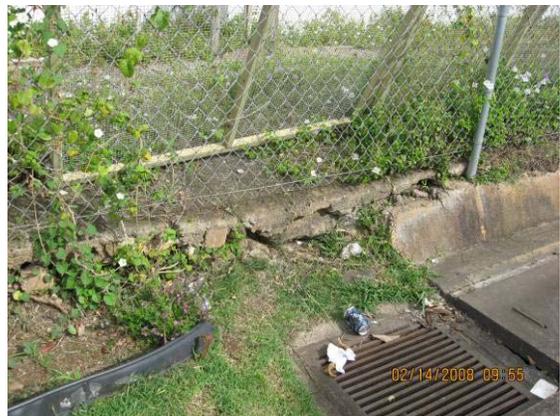
Photo 1: 537

Site Item Name: Retaining/Decorative Walls
Deficiency: damaged
Remedy: Repair
Description:

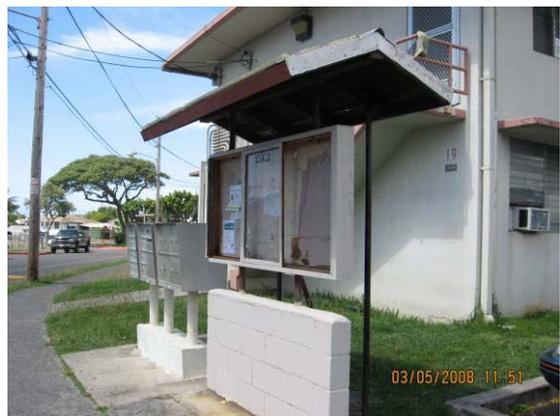
Photo 1: 652

Site Item Name: Project Signage
Deficiency: inadequate
Remedy: Install
Description:

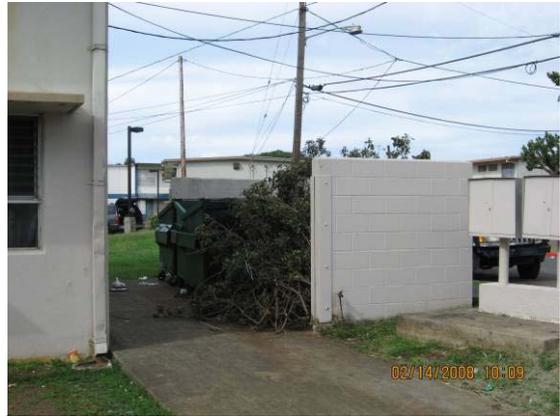
Photo 1: 592

Site Item Name: Trash Enclosures
Deficiency: paint faded
Remedy: Prep/Repaint
Description:

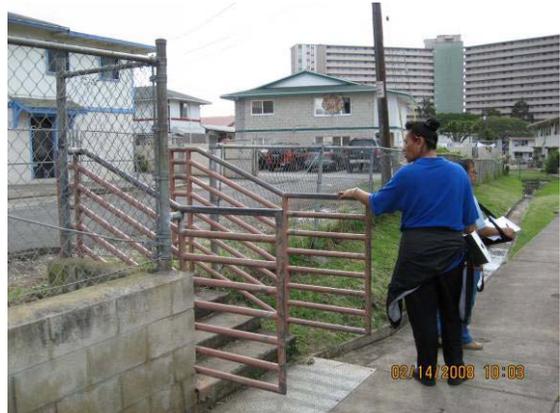
Photo 1: 571

Site Item Name: Ramps
Deficiency: paint faded
Remedy: Prep/Repaint
Description:

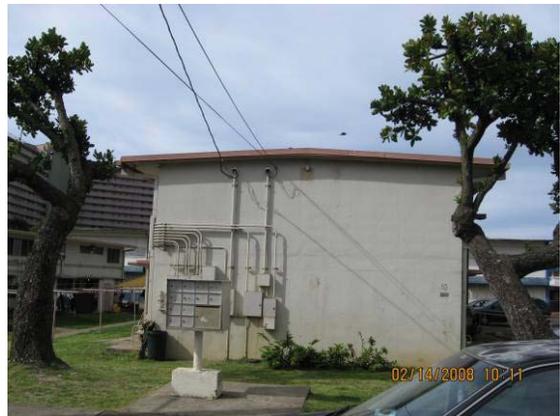
Photo 1: 596

Building ID: 10
Building Exterior Item Name: Lighting
Deficiency: missing
Remedy: Install
Description:

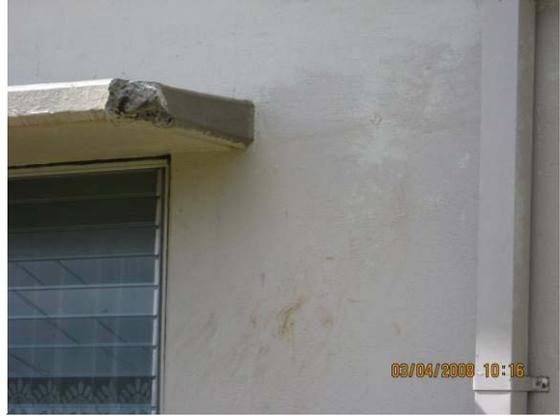
Building ID: 1
Building Exterior Item Name: Other (Description)
Deficiency: cracked/gaps
Remedy: Repair
Description: canopy. Rebar showing. Remove mold & mildew - prep & paint
Photo 1: 632

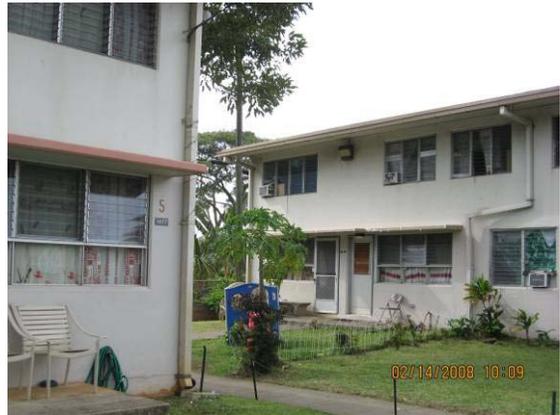
Building ID: 10
Building Exterior Item Name: Other (Description)
Deficiency: spalled
Remedy: Repair
Description: canopy. Clean mold & mildew - paint
Photo 1: 589

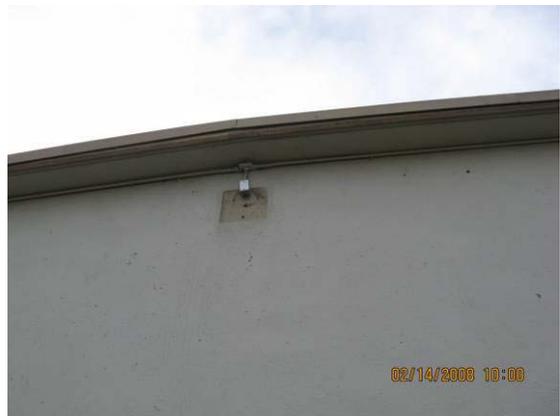
Building ID: 18
Building Exterior Item Name: Lighting
Deficiency: missing
Remedy: Install
Description:
Photo 1: 553

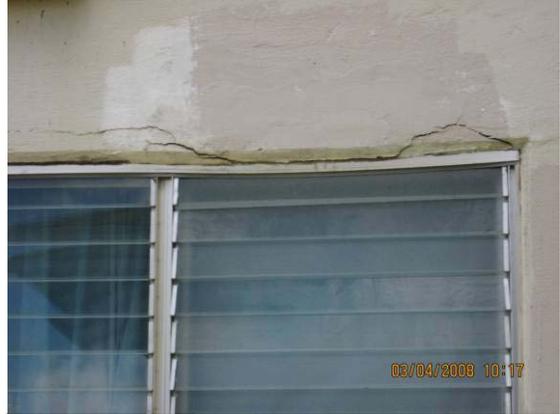
Photo 1: 633

About 20% of the 2 story concrete buildings have major cracks at sill & headers at the exterior windows. About 25% of the entry roof ledge has major cracks to a point where large pieces have broken off thus exposing the rebars.

Building ID: 1
Building Exterior Item Name: Other (Description)
Deficiency: cracked/gaps
Remedy: Repair
Description: window sill & header

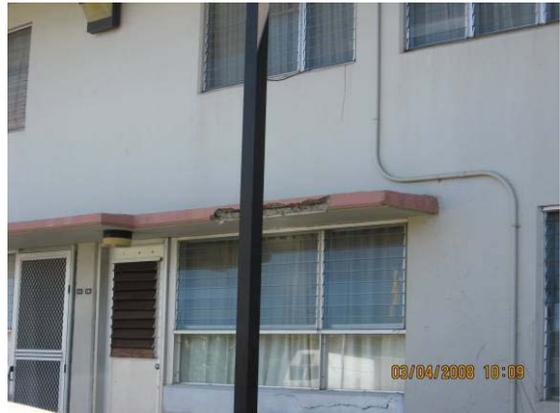
Photo 1: 628

Building ID: 2
Building Exterior Item Name: Other (Description)
Deficiency: cracked/gaps
Remedy: Repair
Description: canopy

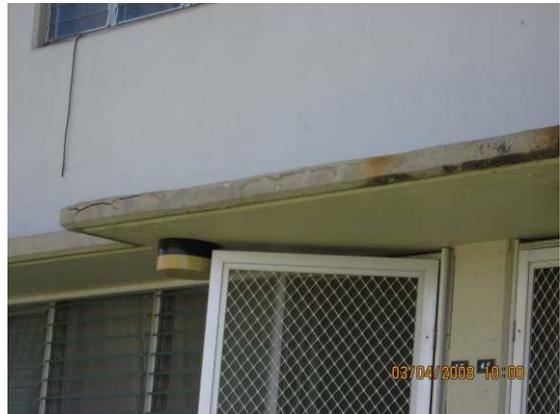
Photo 1: 622

Building ID: 4
Building Exterior Item Name: Other (Description)
Deficiency: spalled
Remedy: Repair
Description: canopy

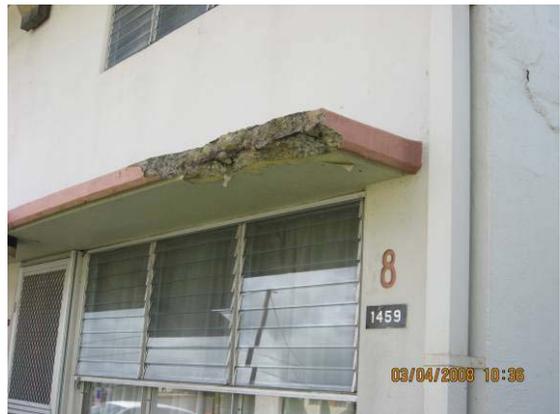
Photo 1: 648

Building ID: 8
Building Exterior Item Name: Other (Description)
Deficiency: spalled
Remedy: Repair
Description: canopy. Rebar showing. clean off mold & mildew - prep & repaint

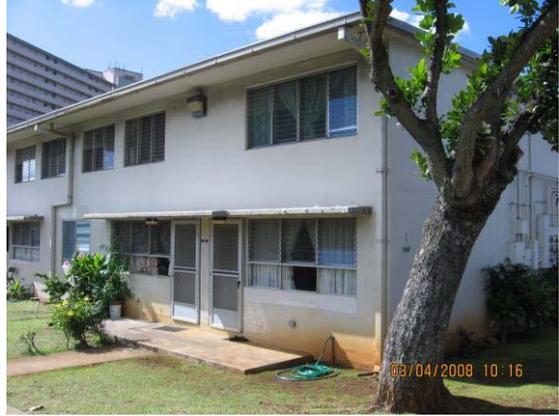
Building ID: 1
Building Exterior Item Name: Gutters/Downspouts
Deficiency: corroded
Remedy: Replace
Description: replace rusted down spout straps (100%)
Photo 1: 630

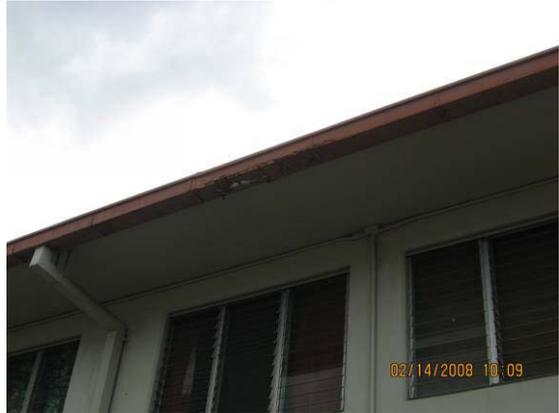
Building ID: 12
Building Exterior Item Name: Other (Description)
Deficiency: cracked/gaps
Remedy: Repair
Description: window sill
Photo 1: 579

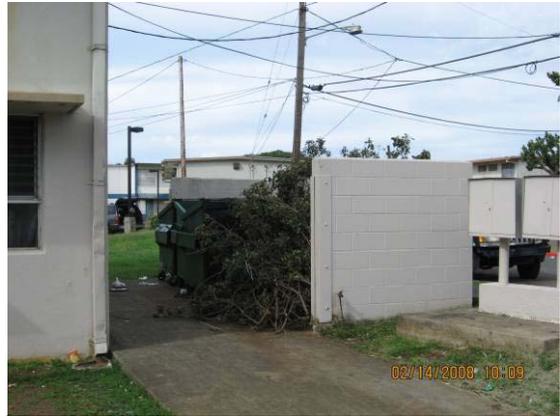
Building ID: 13
Building Exterior Item Name: Gutters/Downspouts
Deficiency: corroded
Remedy: Replace
Description: replace rusted downspout straps (100%). Repair damaged down
Photo 1: 592

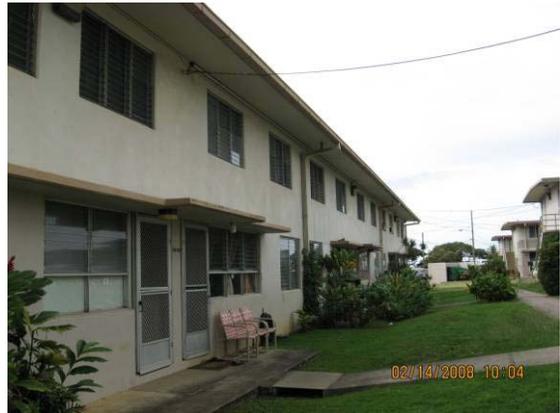
Building ID: 15
Building Exterior Item Name: Gutters/Downspouts
Deficiency: corroded
Remedy: Replace
Description: repair the rest. Replace rusted downspout straps (100%)
Photo 1: 573

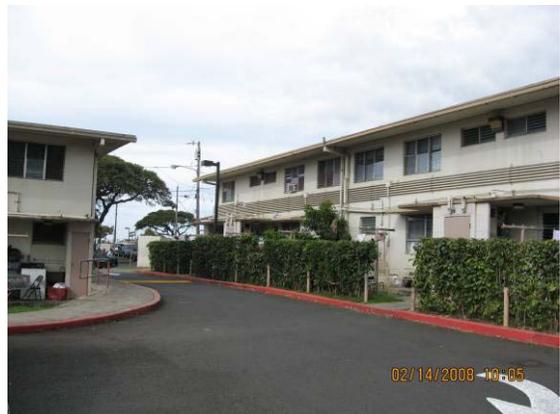
Building ID: 15
Building Exterior Item Name: Other (Description)
Deficiency: excessively weathered
Remedy: Prep/Repaint
Description: doors
Photo 1: 577

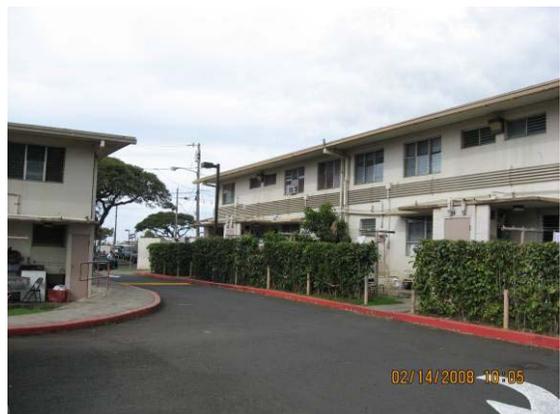
Building ID: 15
Building Exterior Item Name: Other (Description)
Deficiency: excessively weathered
Remedy: Prep/Repaint
Description: electrical conduit
Photo 1: 577

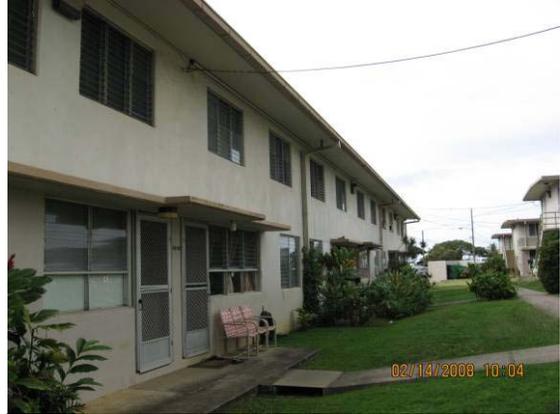
Building ID: 15
Building Exterior Item Name: Other (Description)
Deficiency: spalled
Remedy: Repair
Description: canopy. Remove mold & mildew (prep & repaint)
Photo 1: 573

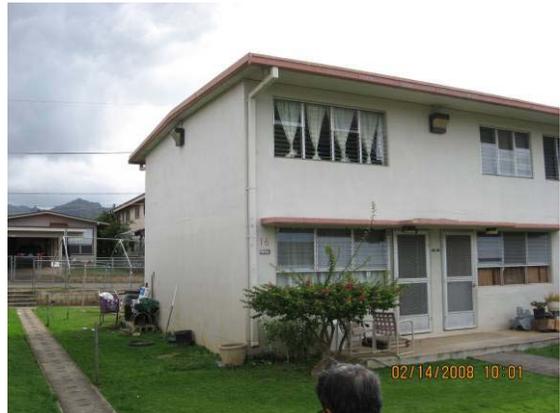
Building ID: 16
Building Exterior Item Name: Gutters/Downspouts
Deficiency: corroded
Remedy: Replace
Description: repair the rest, Replace rusted down spout straps (100%)
Photo 1: 559

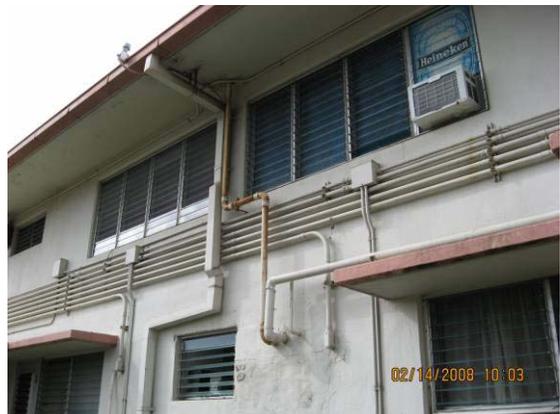
Building ID: 16
Building Exterior Item Name: Other (Description)
Deficiency: corroded
Remedy: Replace
Description: pumbing vent
Photo 1: 570

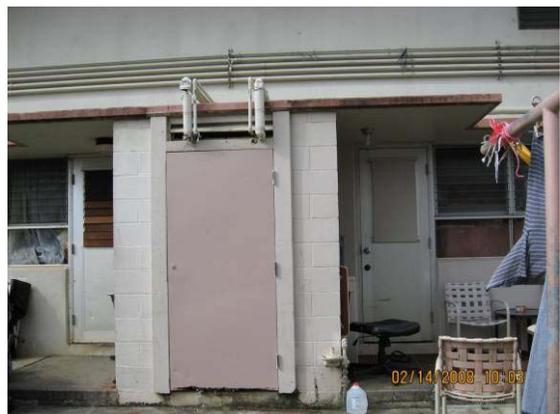
Building ID: 16
Building Exterior Item Name: Other (Description)
Deficiency: excessively weathered
Remedy: Replace
Description: doors. Locks missing on 2 doors
Photo 1: 569

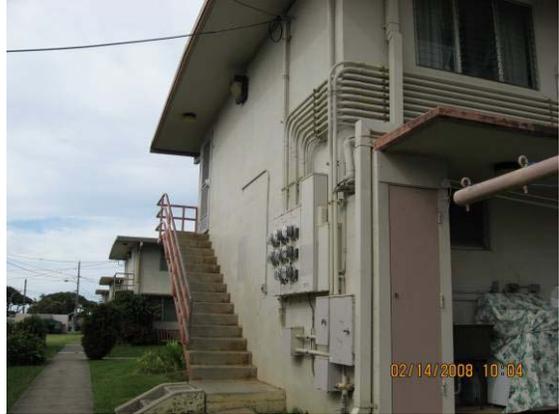
Photo 1: 572

Building ID: 16
Building Exterior Item Name: Other (Description)
Deficiency: paint faded
Remedy: Prep/Repaint
Description: stair rails

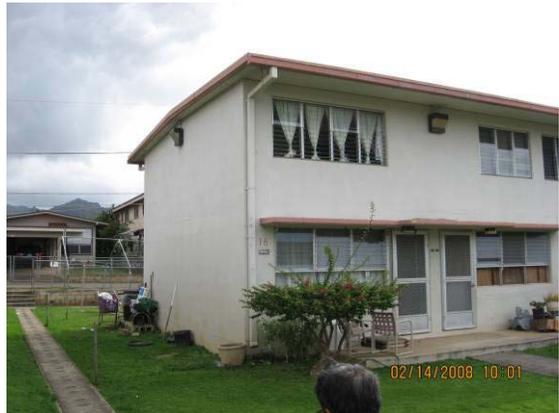
Photo 1: 559

Building ID: 16
Building Exterior Item Name: Other (Description)
Deficiency: spalled
Remedy: Repair
Description: canopy. Clean mold & mildew (100%)

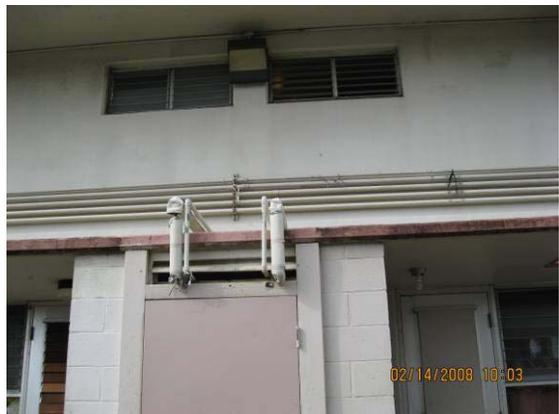
Photo 1: 568

Building ID: 16
Building Exterior Item Name: Other (Description)
Deficiency: Other (Description)
Remedy: Replace
Description: damaged pipe insulation

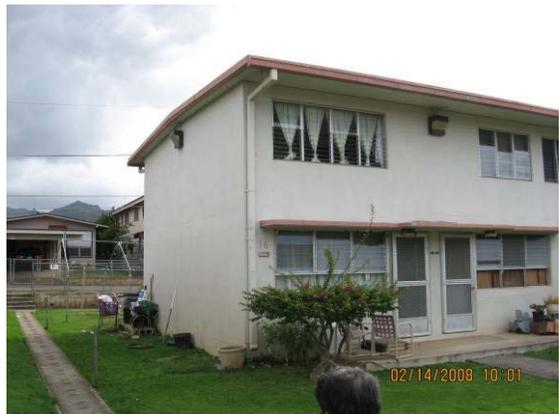
Photo 1: 559

Building ID: 17
Building Exterior Item Name: Gutters/Downspouts
Deficiency: corroded
Remedy: Replace
Description: repair the rest. Replace rusted down spout straps (100%)

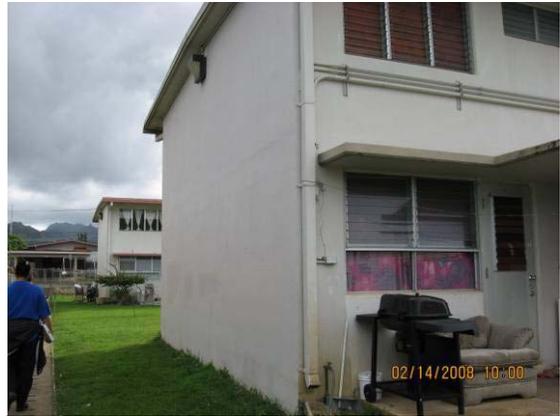
Photo 1: 555

Building ID: 17
Building Exterior Item Name: Other (Description)
Deficiency: mold/mildew
Remedy: Prep/Repaint
Description: canopy/leaves

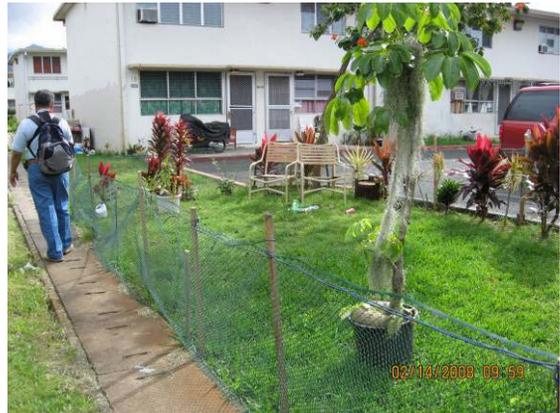
Photo 1: 550

Building ID: 18
Building Exterior Item Name: Gutters/Downspouts
Deficiency: corroded
Remedy: Replace
Description: repair the rest. Replace rusted down spout (100%)

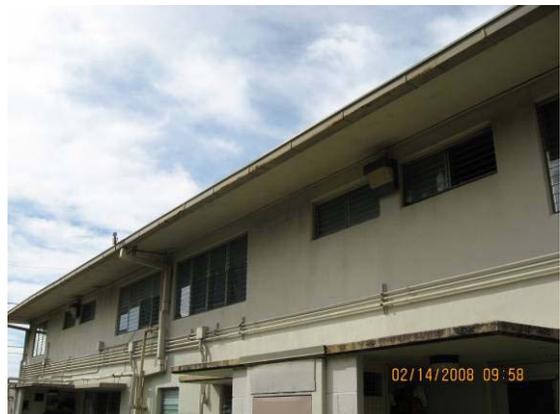
Photo 1: 547

Building ID: 19
Building Exterior Item Name: Other (Description)
Deficiency: mold/mildew
Remedy: Prep/Repaint
Description: canopy

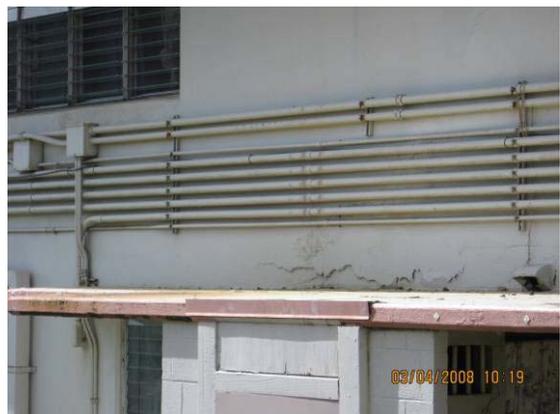
Photo 1: 635

Building ID: 2
Building Exterior Item Name: Gutters/Downspouts
Deficiency: corroded
Remedy: Replace
Description: replace rusted down spout straps (100%)

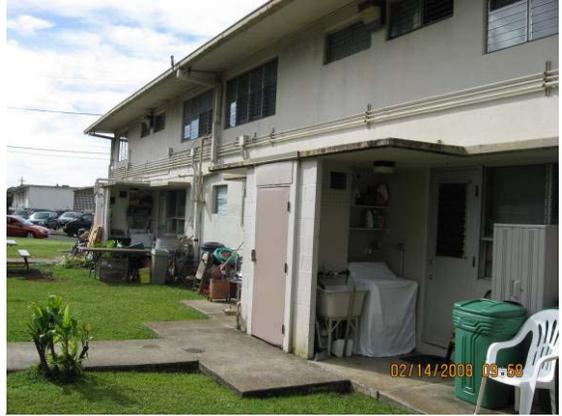
Photo 1: 545

Building ID: 20
Building Exterior Item Name: Roofs
Deficiency: mold/mildew
Remedy: Prep/Repaint
Description: & eaves

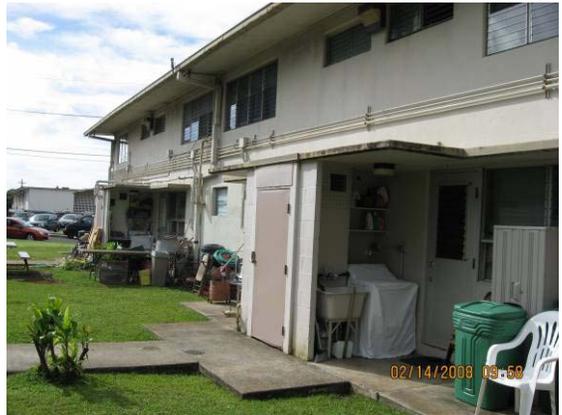
Photo 1: 545

Building ID: 20
Building Exterior Item Name: Gutters/Downspouts
Deficiency: corroded
Remedy: Replace
Description: repair the rest. Replace all gutter straps

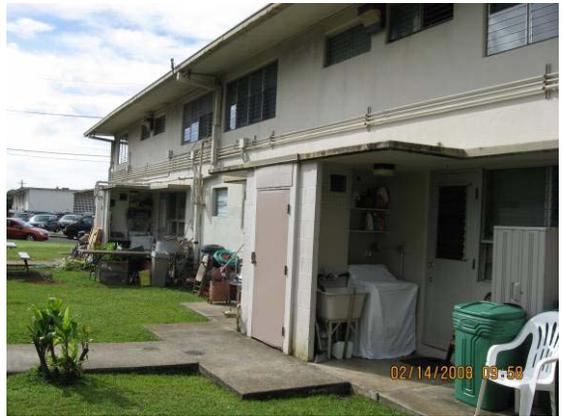
Photo 1: 545

Building ID: 20
Building Exterior Item Name: Other (Description)
Deficiency: excessively weathered
Remedy: Prep/Repaint
Description: doors

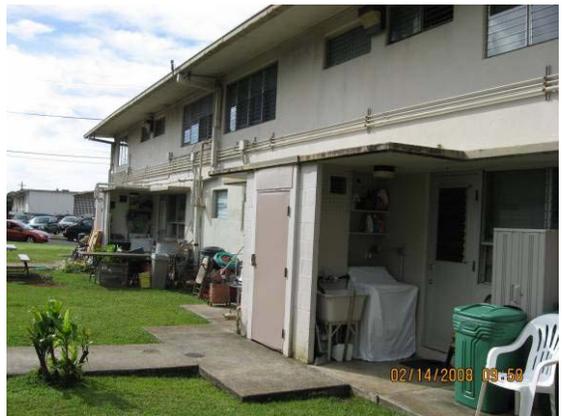
Photo 1: 545

Building ID: 20
Building Exterior Item Name: Other (Description)
Deficiency: spalled
Remedy: Repair
Description: canopy/eave

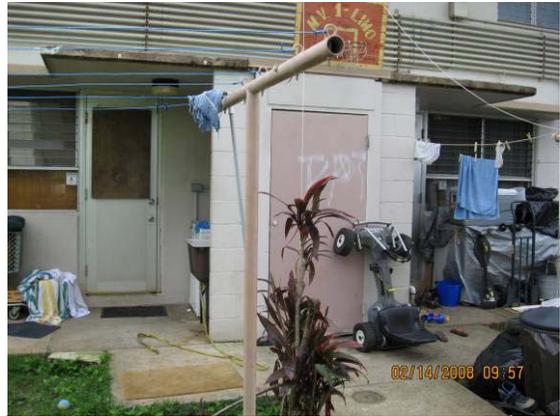
Photo 1: 543

Building ID: 21
Building Exterior Item Name: Other (Description)
Deficiency: excessively weathered
Remedy: Prep/Repaint
Description: doors

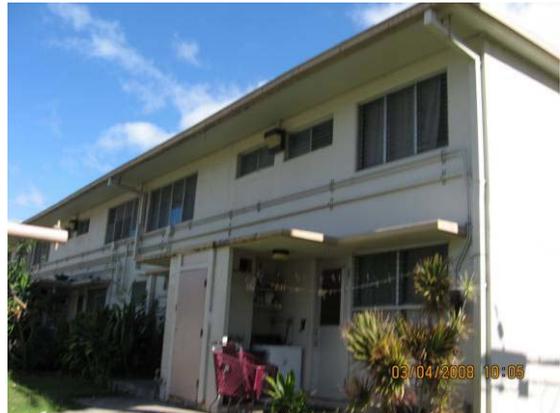
Photo 1: 624

Building ID: 3
Building Exterior Item Name: Gutters/Downspouts
Deficiency: corroded
Remedy: Replace
Description: replace rusted down spout straps (100%)

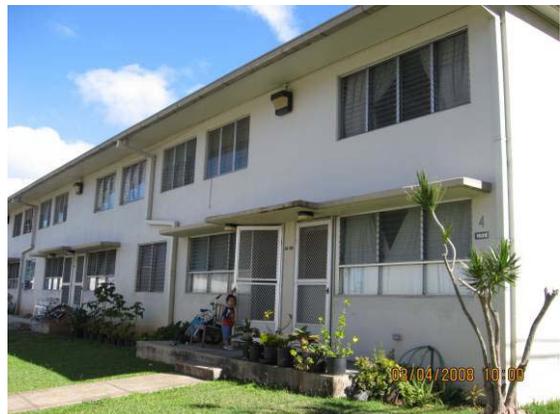
Photo 1: 621

Building ID: 4
Building Exterior Item Name: Gutters/Downspouts
Deficiency: corroded
Remedy: Replace
Description: replace rusted down spout straps (100%)

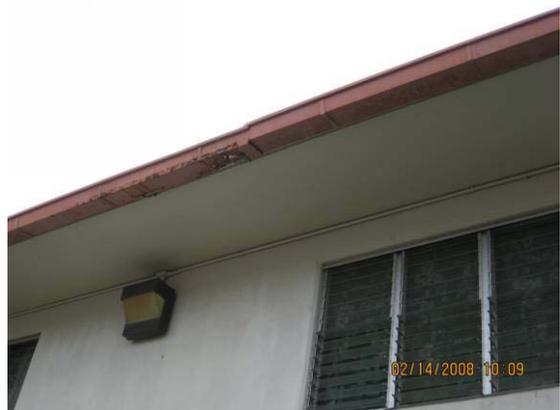
Photo 1: 588

Building ID: 5
Building Exterior Item Name: Gutters/Downspouts
Deficiency: corroded
Remedy: Replace
Description: repair the rest. Replace rusted downspout straps (100%)

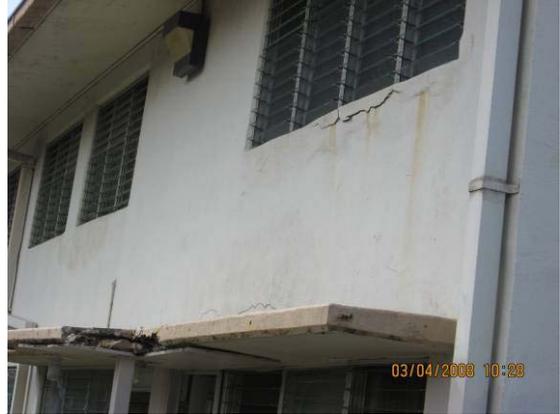
Building ID: 6
Building Exterior Item Name: Other (Description)
Deficiency: cracked/gaps
Remedy: Repair
Description: clean mold & mildew - prep & paint
Photo 1: 645

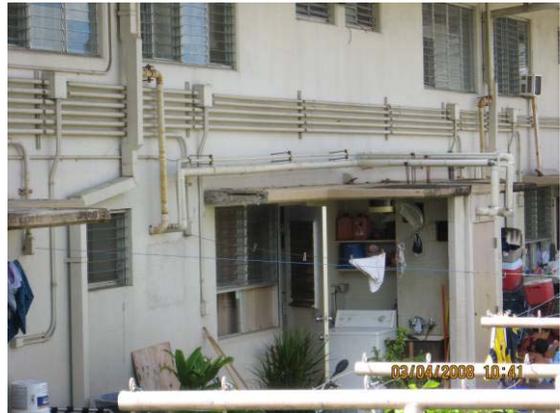
Building ID: 9
Building Exterior Item Name: Other (Description)
Deficiency: cracked/gaps
Remedy: Repair
Description: canopy. Remove mold & mildew - prep & repaint
Photo 1: 651

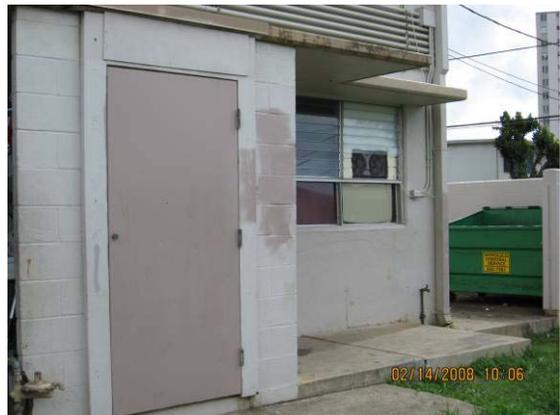
Building ID: 12
Building Exterior Item Name: Walls
Deficiency: paint faded
Remedy: Prep/Repaint
Description:
Photo 1: 581

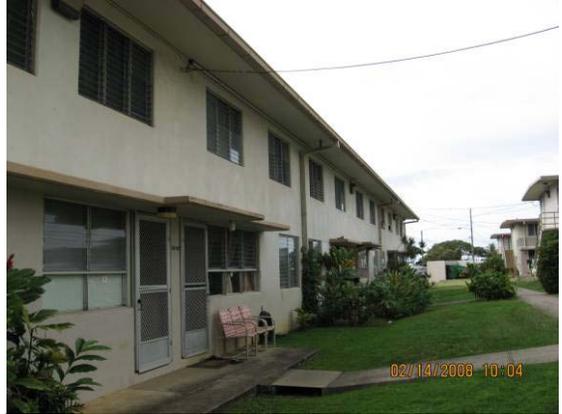
Photo 1: 573

Building ID: 15
Building Exterior Item Name: Walls
Deficiency: paint faded
Remedy: Prep/Repaint
Description:

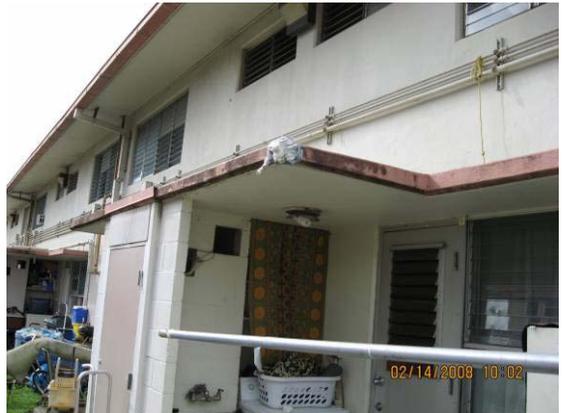
Photo 1: 564

Building ID: 16
Building Exterior Item Name: Walls
Deficiency: paint faded
Remedy: Prep/Repaint
Description:

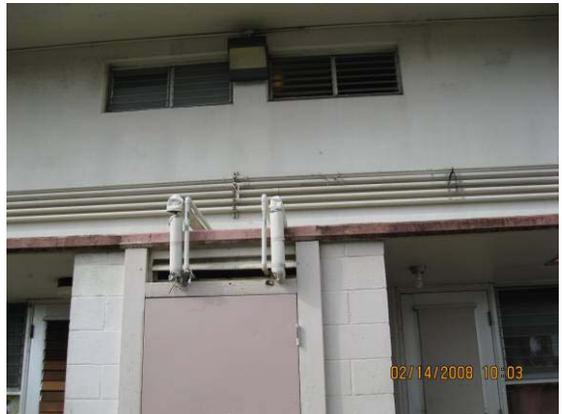
Photo 1: 568

Building ID: 16
Building Exterior Item Name: Other (Description)
Deficiency: excessively weathered
Remedy: Prep/Repaint
Description: electrical conduits

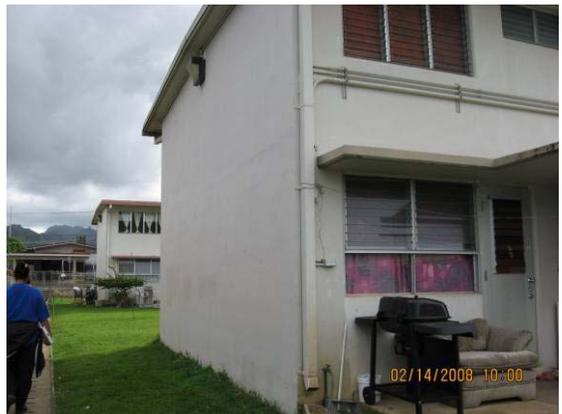
Photo 1: 555

Building ID: 17
Building Exterior Item Name: Walls
Deficiency: paint faded
Remedy: Prep/Repaint
Description:

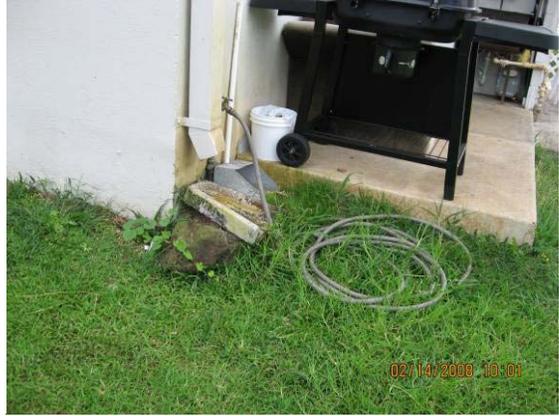
Building ID: 17
Building Exterior Item Name: Other (Description)
Deficiency: Other (Description)
Remedy:
Description: gutter spout to far from splash block - bring closer
Photo 1: 556

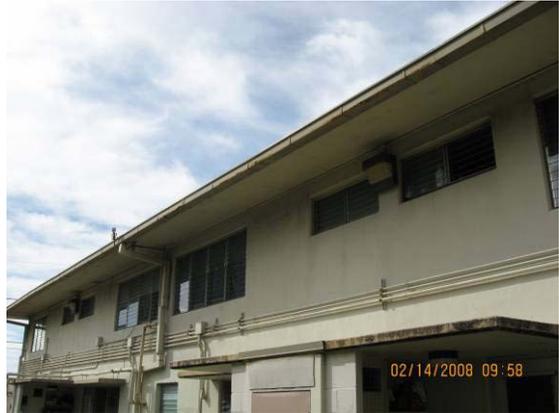
Building ID: 20
Building Exterior Item Name: Walls
Deficiency: paint faded
Remedy: Prep/Repaint
Description:
Photo 1: 545

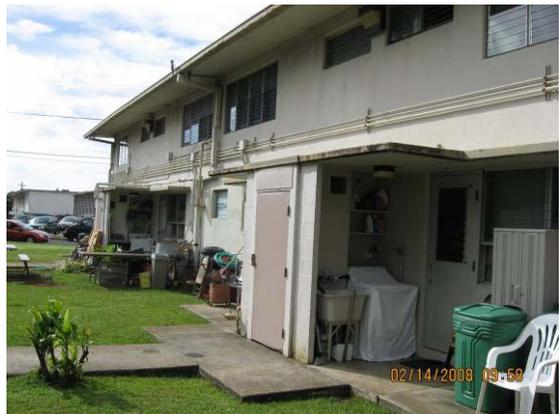
Building ID: 20
Building Exterior Item Name: Gutters/Downspouts
Deficiency: corroded
Remedy: Replace
Description: repair the rest & replace down spout straps
Photo 1: 545

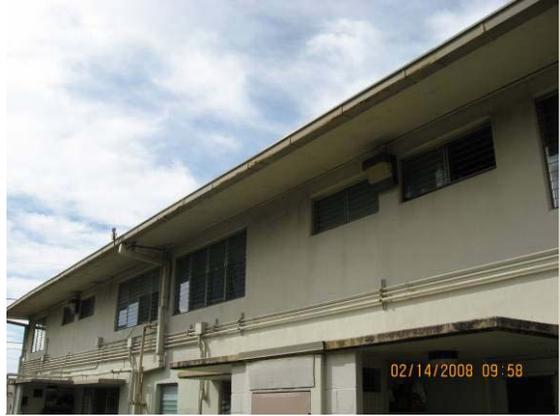
Photo 1: 547

Building ID: 20
Building Exterior Item Name: Other (Description)
Deficiency: excessively weathered
Remedy: Prep/Repaint
Description: electrical conduit pipes

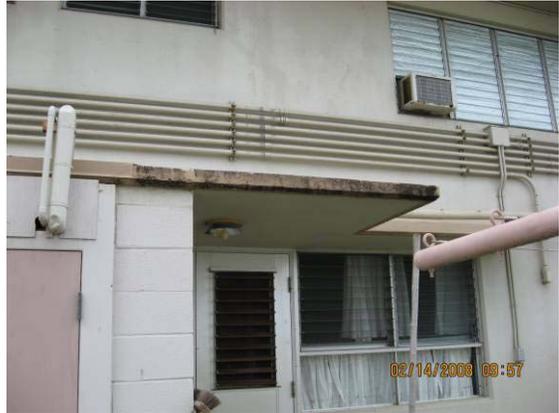
Photo 1: 541

Building ID: 21
Building Exterior Item Name: Other (Description)
Deficiency: corroded
Remedy: Prep/Repaint
Description: exposed pipes. 25% corroded & replace insulation

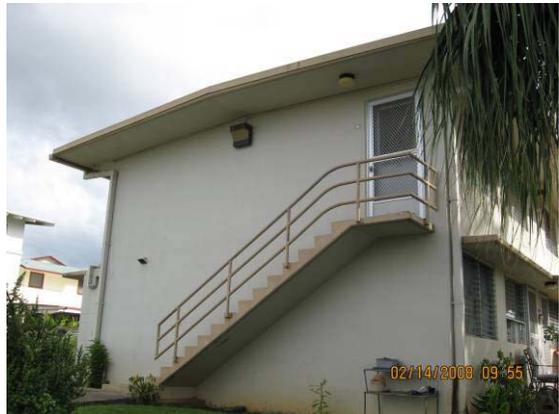
Photo 1: 532

Building ID: 21
Building Exterior Item Name: Other (Description)
Deficiency: excessively weathered
Remedy: Prep/Repaint
Description: stair handrail

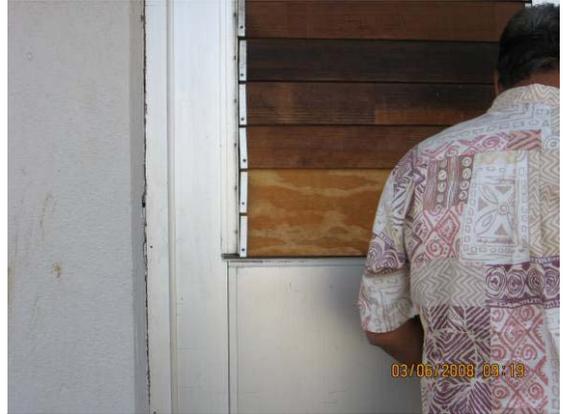
Photo 1: 691

Description: louvers

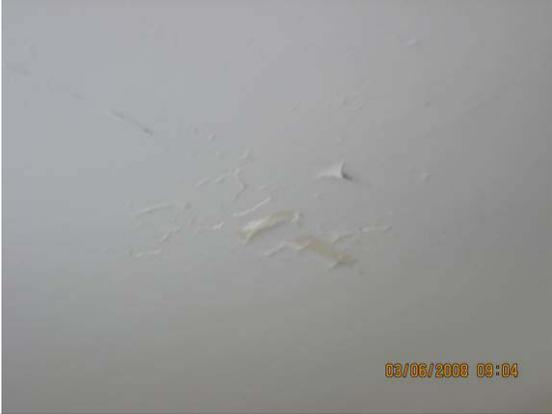
Living/Dining Item Name:	Ceiling	
Deficiency:	paint peeled	
Remedy:	Prep/Repaint	
Description:		
Photo 1:	680

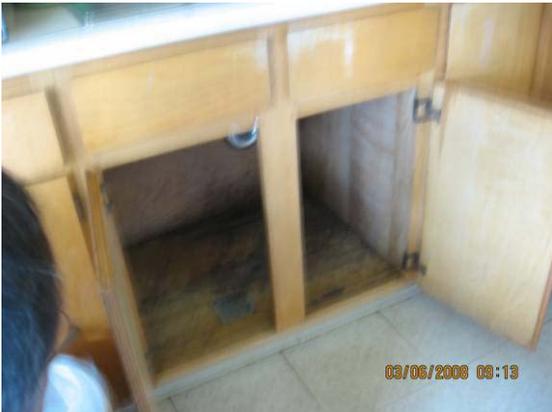
Kitchen Item Name:	Sink	
Deficiency:	damaged	
Remedy:	Repair	
Description:	water leaking from floor above - damaged cabinet	
Photo 1:	688

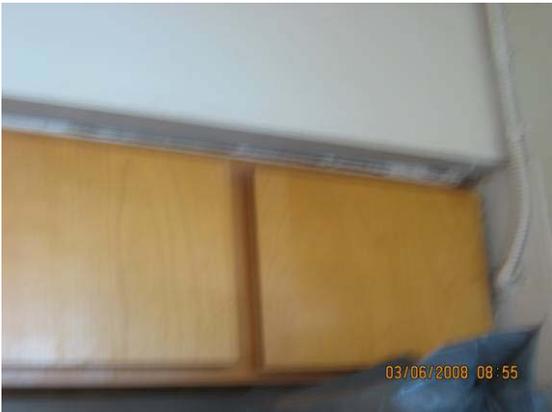
Kitchen Item Name:	Cabinets	
Deficiency:	damaged	
Remedy:	Repair	
Description:		
Photo 1:	673

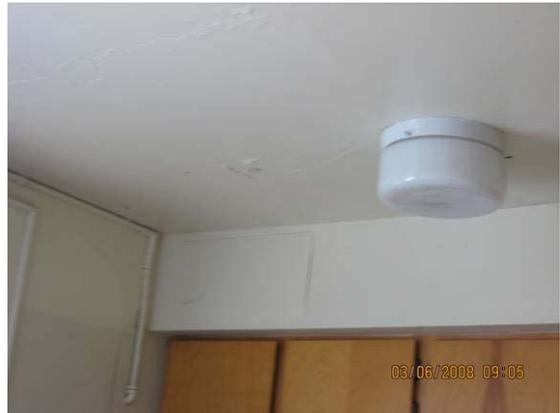
Photo 1: 681

Building ID: 4 **UnitID:** 4a
Kitchen Item Name: Ceiling
Deficiency: paint peeled
Remedy: Prep/Repaint
Description:

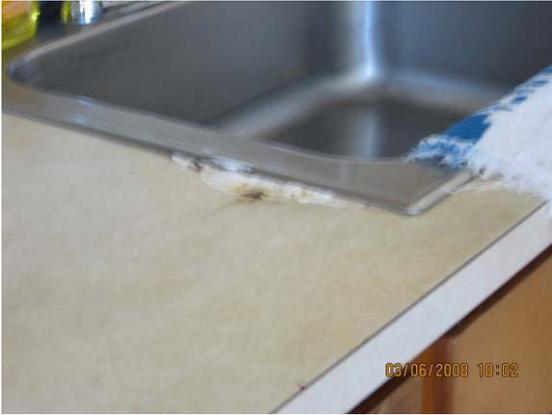
Kitchen Item Name:	Countertops			
Deficiency:	damaged			
Remedy:	Replace			
Description:				
Photo 1:	713			
Building ID: bldg 17	UnitID: 17e

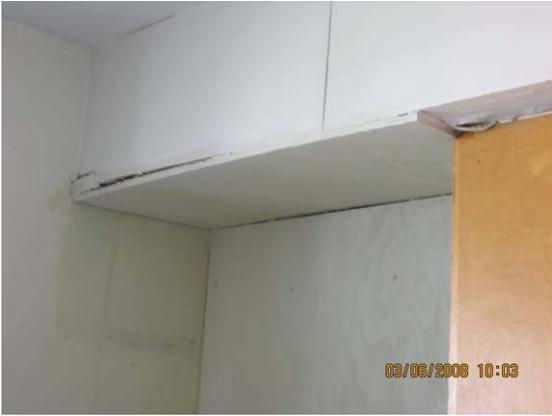
Kitchen Item Name:	Ceiling			
Deficiency:	damaged			
Remedy:	Repair			
Description:				
Photo 1:	716			
Urgency:		Short Term		1 Year

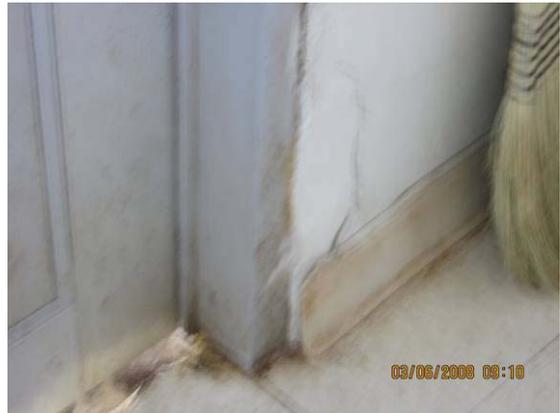
Photo 1: 686

Building ID: 4 **UnitID:** 4c
Kitchen Item Name: Walls
Deficiency: cracked/gaps
Remedy: Repair
Description:

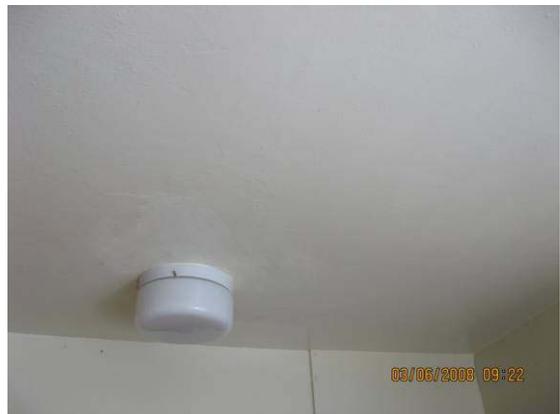
Photo 1: 695

Building ID: 5 **UnitID:** 5f
Kitchen Item Name: Ceiling
Deficiency: damaged
Remedy: Repair
Description:

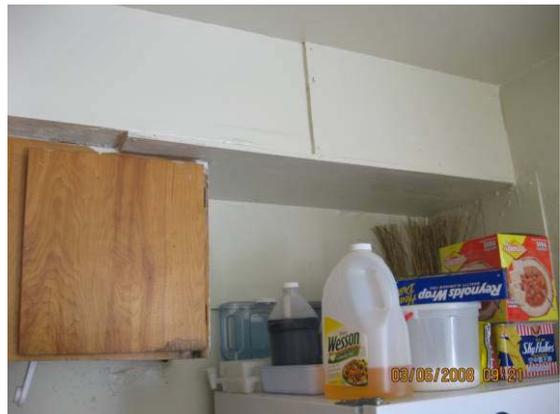
Photo 1: 692

Building ID: 5 **UnitID:** 5f
Kitchen Item Name: Walls
Deficiency: damaged
Remedy: Repair
Description: above cabinet

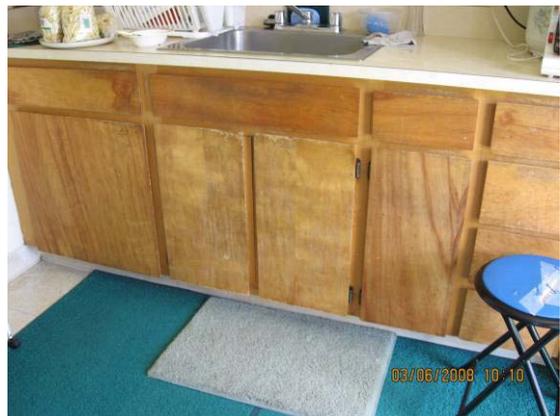
Photo 1: 721

Deficiency: Other (Description)

Description: Replace to match existing

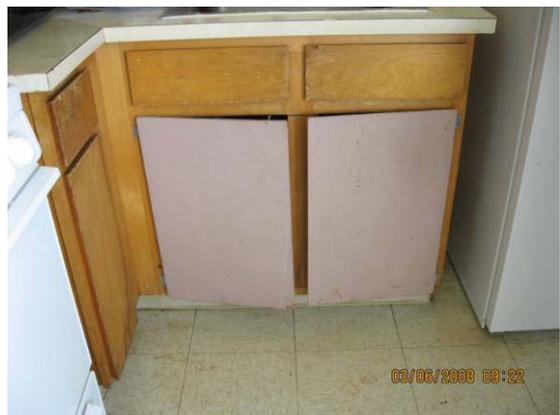
Photo 1: 694

Description: replace door to match existing

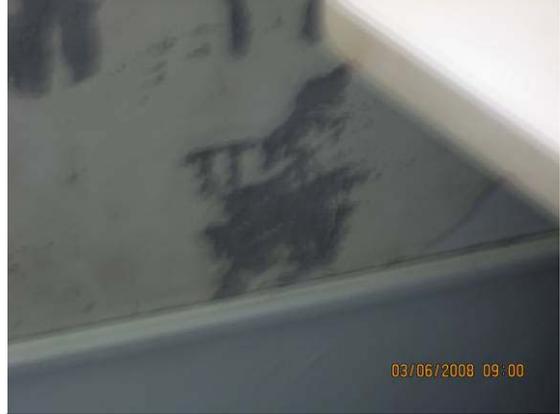
Photo 1: 678

Building ID: 1 **UnitID:** 1f **Bedroom Number:** 1
Bedroom Item Name: Walls
Deficiency: paint peeled
Remedy: Prep/Repaint
Description:

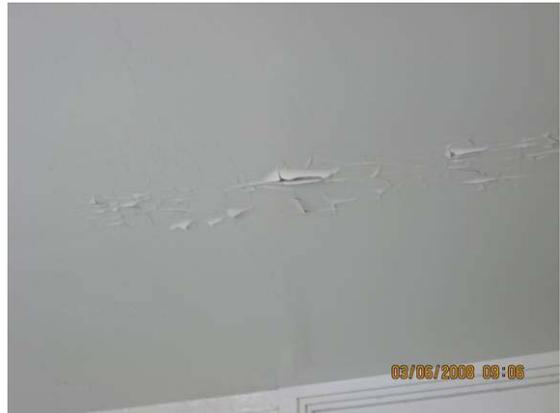
Photo 1: 683

Building ID: 4 **UnitID:** 4a **Bedroom Number:** 1
Bedroom Item Name: Ceiling
Deficiency: paint faded
Remedy: Prep/Repaint
Description:

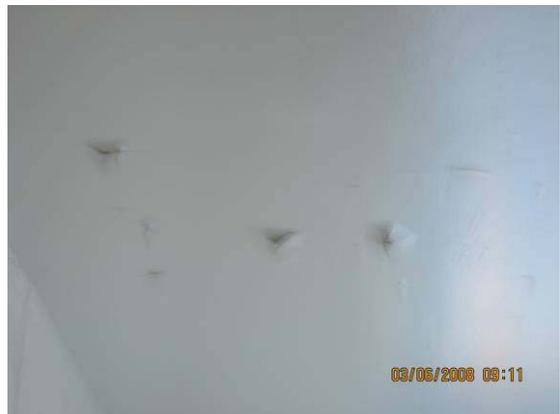
Photo 1: 687

Building ID: 4 **UnitID:** 4c **Bedroom Number:** 1
Bedroom Item Name: Ceiling
Deficiency: paint peeled
Remedy: Prep/Repaint
Description:

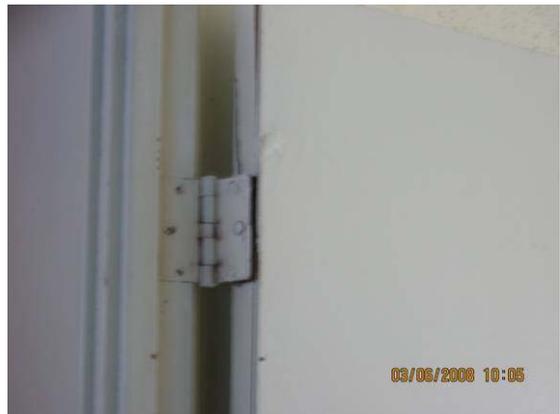
Photo 1: 719

Building ID: bldg 17 **UnitID:** 17e **Bedroom Number:** 1
Bedroom Item Name: Door
Deficiency: broken
Remedy: Replace
Description:

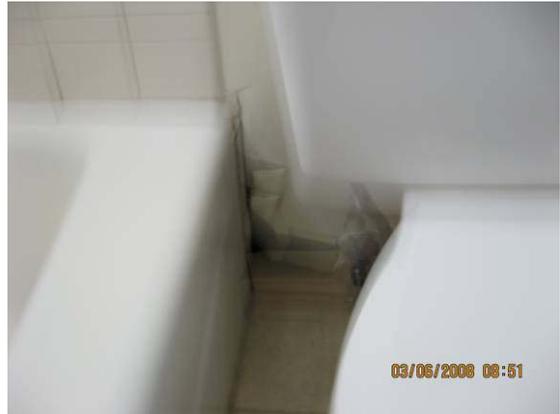
Building ID: 1 Unit ID: 1a Bathroom Number: 1
 Bathroom Item Name: Walls
 Deficiency: damaged
 Remedy: Repair
 Description:
 Photo 1: 668

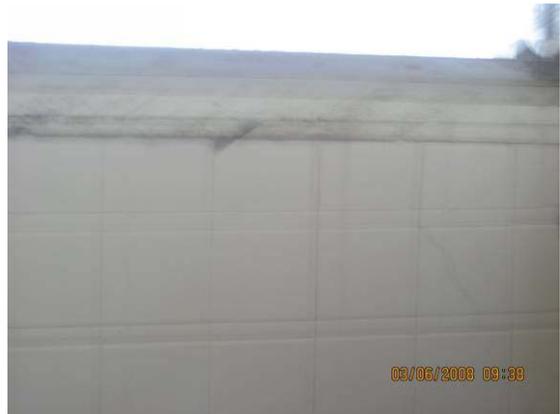
Building ID: bldg 13 Unit ID: 13e Bathroom Number:
 Bathroom Item Name: Tub/Surround
 Deficiency: cracked/gaps
 Remedy: Repair
 Description: Re-grout, reseal
 Photo 1: 702

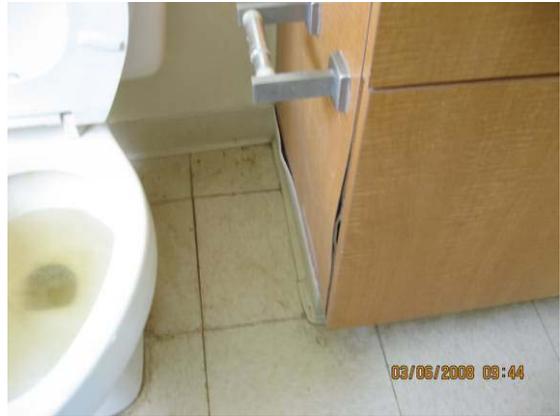
Photo 1: 706

Building ID: bldg 14 **Unit ID:** 14d **Bathroom Number:**
Bathroom Item Name: Cabinets
Deficiency: damaged
Remedy: Replace
Description:

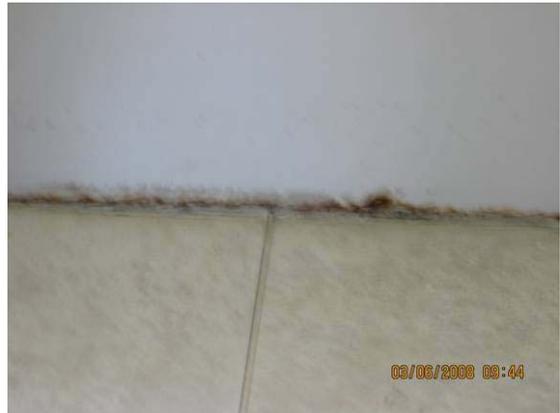
Photo 1: 705

Building ID: bldg 14 **Unit ID:** 14d **Bathroom Number:**
Bathroom Item Name: Floor Covering
Deficiency: damaged
Remedy: Replace
Description:

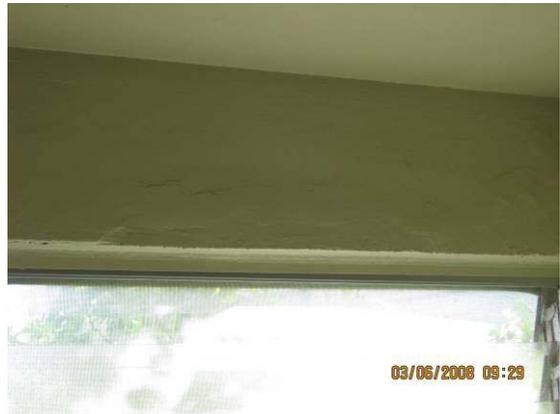
Photo 1: 699

Building ID: bldg 7 **Unit ID:** 7d **Bathroom Number:** 1
Bathroom Item Name: Windows
Deficiency: damaged
Remedy: Repair
Description:
