2008 Physical Needs Assessment and Energy Audit For Federally Assisted Projects

Kuhio Park Terrace

HPHA Project Number HIOP001010

Honolulu Oahu

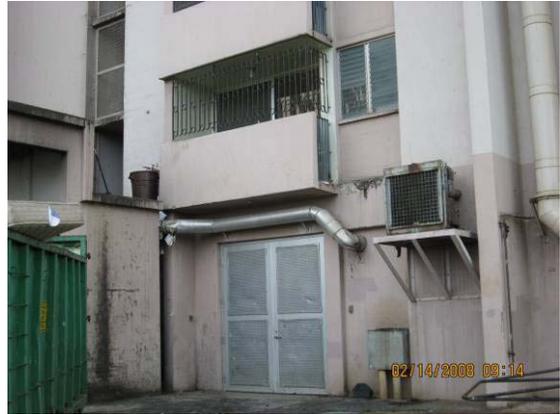
Building ID: bldg A3
Building Exterior Item Name: Other (Description)
Deficiency: damaged
Remedy: Replace
Description: trash chute vent
Photo 1: 384

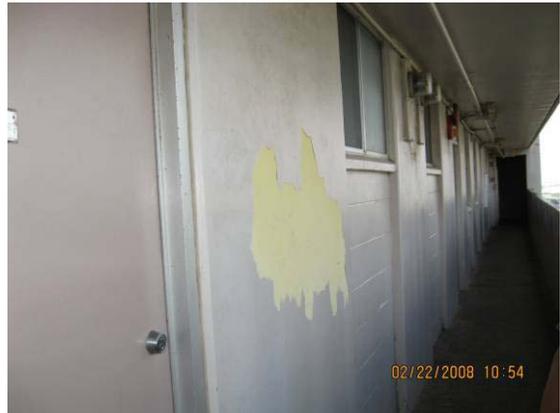
Building ID: bldgB
Building Exterior Item Name: Walls
Deficiency: paint faded
Remedy: Prep/Repaint
Description: Paint all
Photo 1: 876

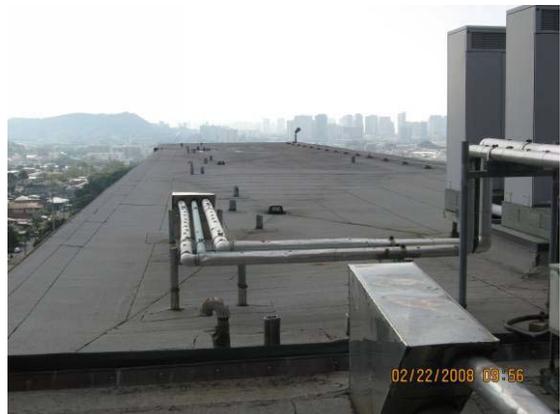
Building ID: bldgB
Building Exterior Item Name: Roofs
Deficiency: corroded
Remedy: Replace
Description: Weathered concrete-Repair and fill.
Flashing replace
Photo 1: 860

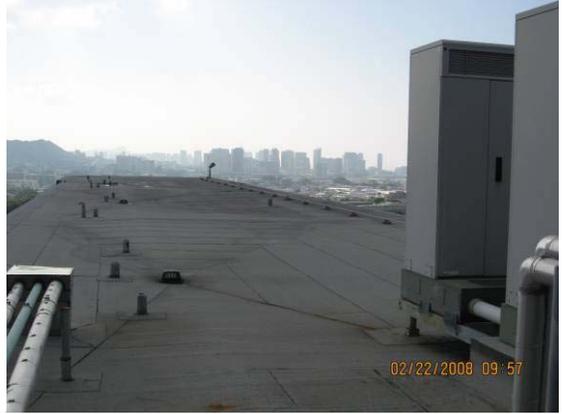
Building ID: bldgB
Building Exterior Item Name: Roofs
Deficiency: excessively weathered
Remedy: Replace
Description: Water ponding, weeds growing, existing solar pipes leaking/not being used
Photo 1: 862

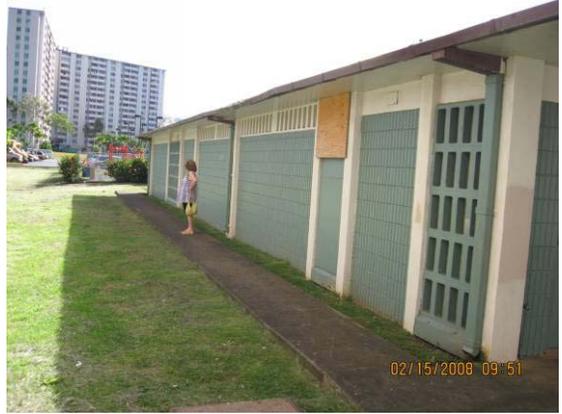
Building ID: Comm bldg
Building Exterior Item Name: Walls
Deficiency: paint faded
Remedy: Prep/Repaint
Description: Graffiti, Roof eaves-prep/paint Lighting
Photo 1: 759

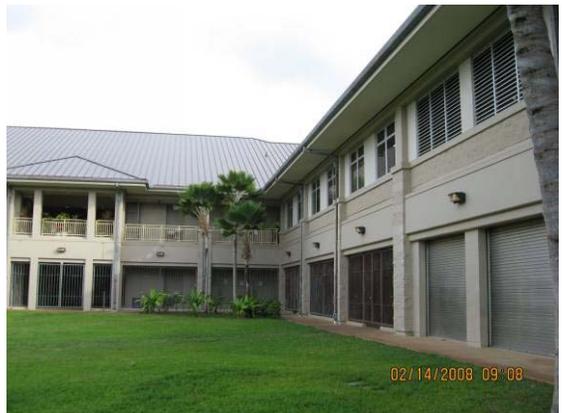
Building ID: H.Resource
Building Exterior Item Name: Gutters/Downspouts
Deficiency: corroded
Remedy: Replace
Description: Downspout/gutter-replace corroded portion
Photo 1: 370

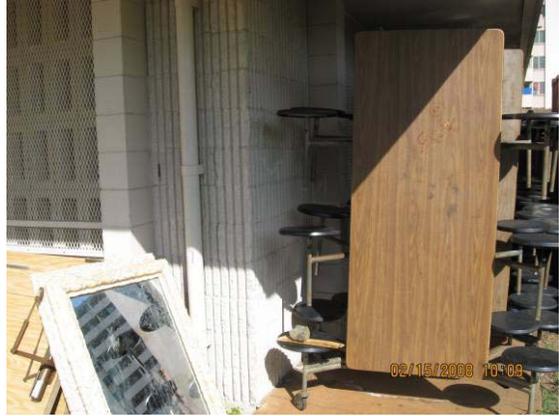
Building ID: Teen Ctr
Building Exterior Item Name: Walls
Deficiency: paint faded
Remedy: Prep/Repaint
Description: Graffiti on walls
Weeds@ roof
Roof Sump
Photo 1: 794

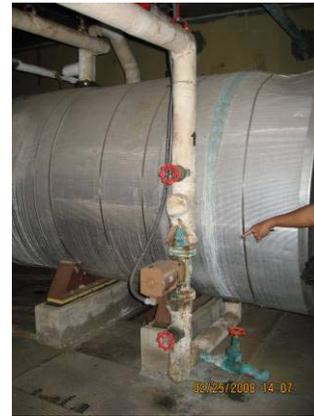
Building ID: bldg A
Building Systems Item Name: Other (Description)
Deficiency: corroded
Remedy: Replace
Description: BOILER RM-clng-water stain damages, walls prep/repaint, floor steel plates,
Photo 1: 968

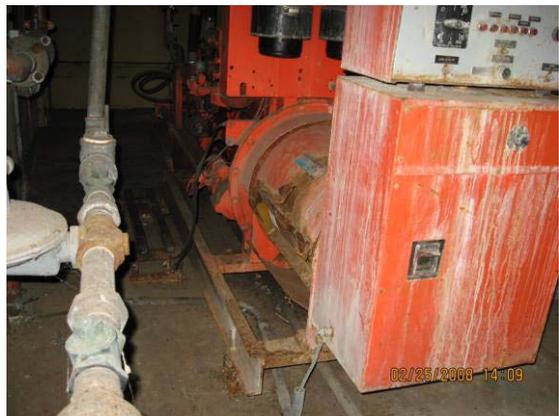
Building ID: bldg A
Building Systems Item Name: Other (Description)
Deficiency: inadequate
Remedy: Other (Description)
Description: BOILER RM-generator-not operable,steel base-corroded
Photo 1: 971

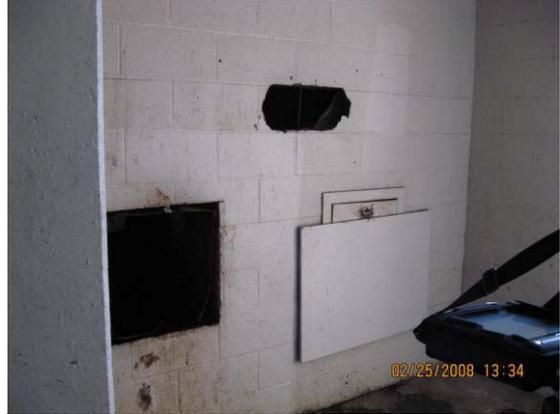
Building ID: bldg A
CommonAreaName: Refuse Room
CommonArealtem: Trash Chute
Deficiency: damaged
Remedy: Repair
Description: 4th floor-missing door, wall-damaged, floor-filthy, clean sanitize (foul smell)
Photo 1: 958

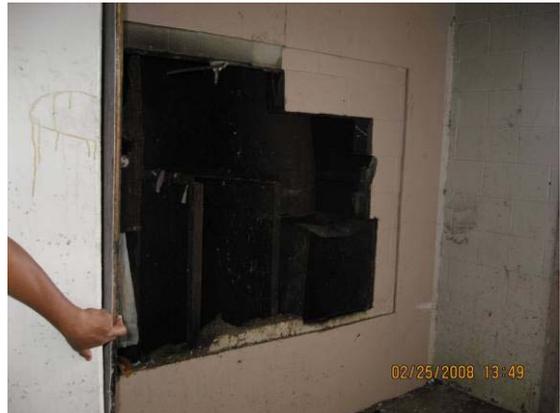
Building ID: bldg A
CommonAreaName: Refuse Room
CommonArealtem: Trash Chute
Deficiency: damaged
Remedy: Repair
Description: 3rd floor-walls-replaced & paint, door-replaced, floor-clean, sanitize
Photo 1: 962

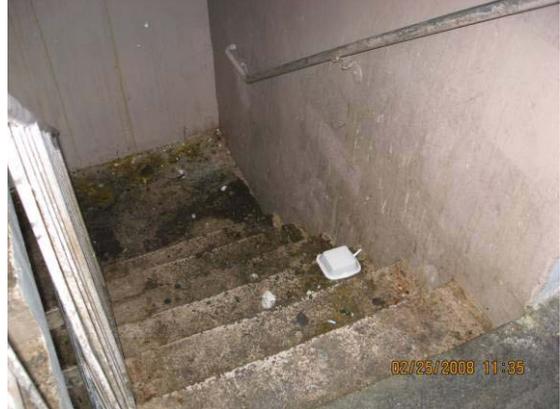
Building ID: bldg A
CommonAreaName: Stairs
CommonArealtem: Walls
Deficiency: odorous
Remedy: Other (Description)
Description: walls-repaint, sanblast, railing-prep/repaint
Photo 1: 953

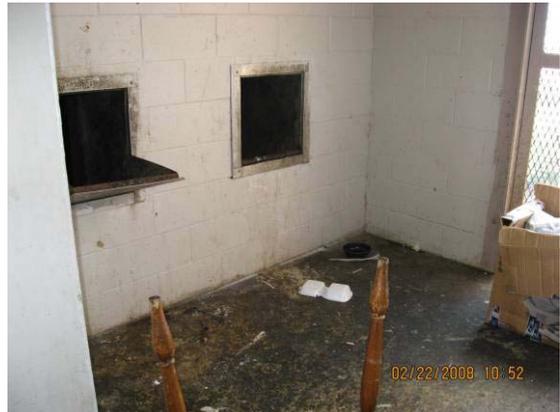
Building ID: bldg B
CommonAreaName: Refuse Room
CommonArealtem: Trash Chute
Deficiency: Other (Description)
Remedy: Repair
Description: 14th floor-dr replace, floor renished, clean & sanitize walls clean, sanitize & paint
Photo 1: 875

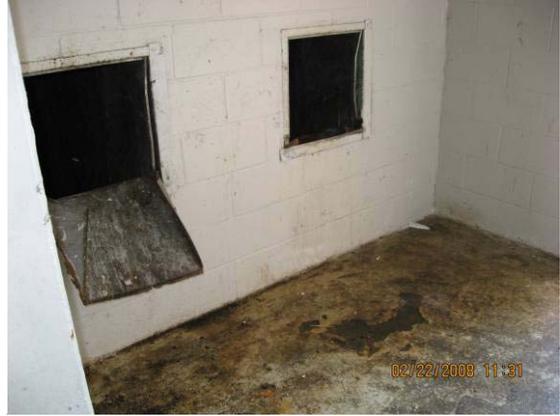
Building ID: bldg B
CommonAreaName: Refuse Room
CommonArealtem: Trash Chute
Deficiency: damaged
Remedy: Repair
Description: 10th floor- door replaced, walls prep/paint, floor clean, sanitize
Photo 1: 885

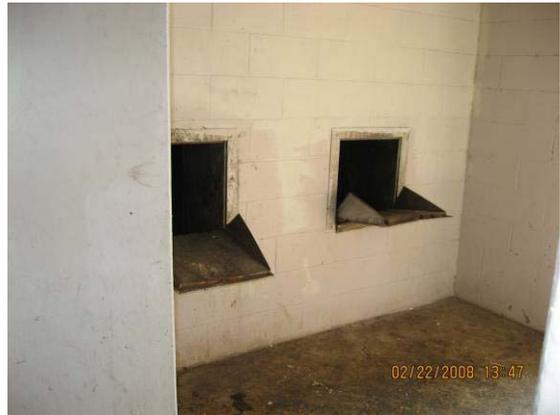
Building ID: bldg B
CommonAreaName: Refuse Room
CommonArealtem: Trash Chute
Deficiency: damaged
Remedy: Repair
Description: 8th floor-door replace, walls clean, prep/paint. Floor refinish, clean, sanitize & reseal
Photo 1: 891

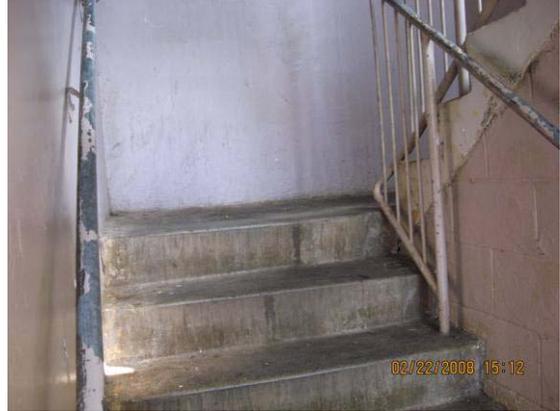
Building ID: bldg B
CommonAreaName: Stairs
CommonArealtem: Other (Description)
Deficiency: Other (Description)
Remedy: Repair
Description: 1st floor-tread/riser, landing-clean, sanitize, patch & fill. Handrail prep/paint
Photo 1: 904

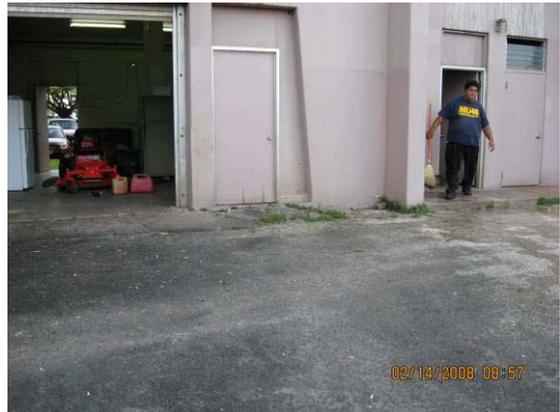
Building ID: bldgA
CommonAreaName: Other (Description)
CommonArealtem: Other (Description)
Deficiency: odorous
Remedy:
Description: Maintenance room inadequate
Photo 1: 340

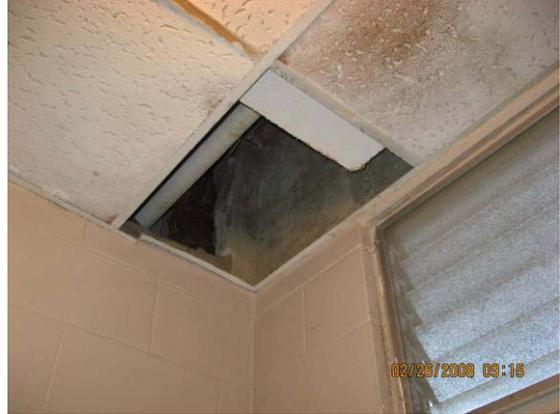
Photo 1: 995

Building ID: bldg A
CommonAreaName: Restrooms
CommonArealtem: Ceiling
Deficiency: bulging/buckling/sagging
Remedy: Replace
Description: prep/paint

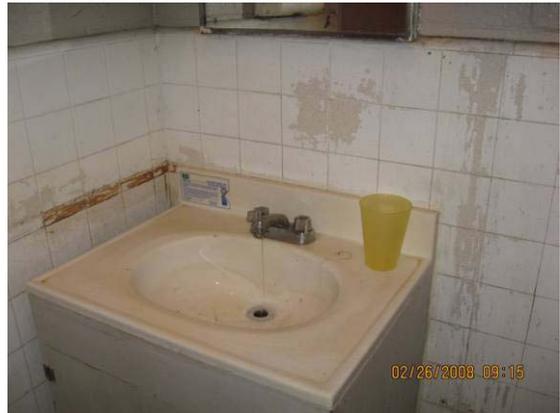
Photo 1: 994

Building ID: bldg A
CommonAreaName: Restrooms
CommonArealtem: Walls
Deficiency: paint peeled
Remedy: Prep/Repaint
Description:

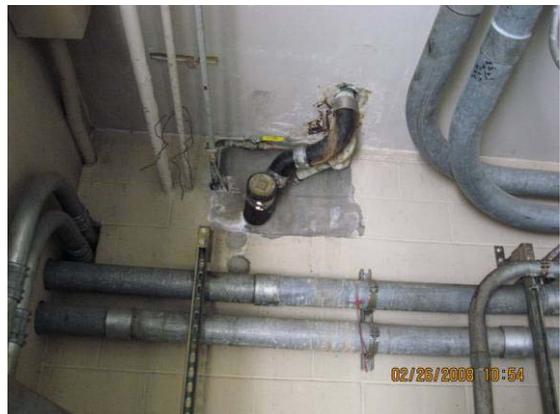
Photo 1: 1023

Building ID: bldg A
CommonAreaName: Electrical Rooms
CommonArealtem: Ceiling
Deficiency: water stained/damaged
Remedy: Repair
Description: check source of leakage

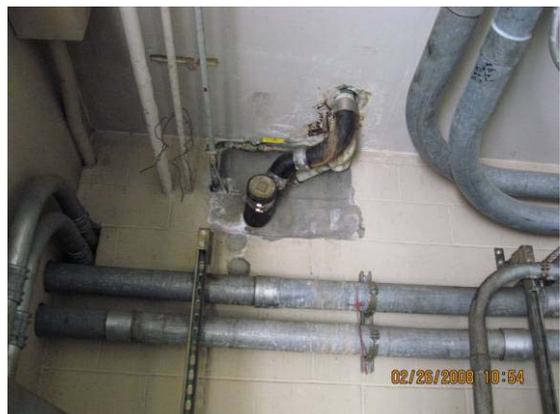
Photo 1: 1023

Building ID: bldg A
CommonAreaName: Electrical Rooms
CommonArealtem: Ceiling
Deficiency: water stained/damaged
Remedy: Repair
Description: wall-repair, prep/repaint

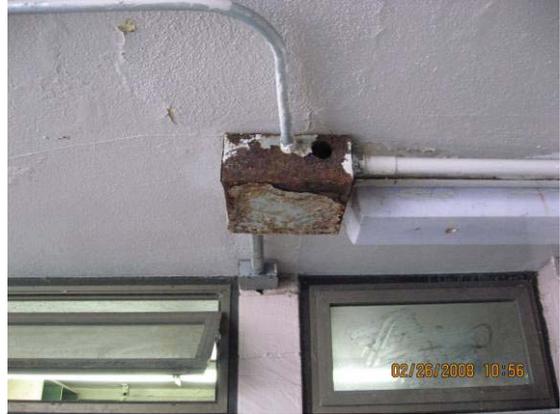
Building ID: bldg A
CommonAreaName: Lobby
CommonArealtem: Ceiling
Deficiency: cracked/gaps
Remedy: Replace
Description: Ground Floor Entry-exposed elect conduits, lighting, cracked,peeled.
Photo 1: 1026

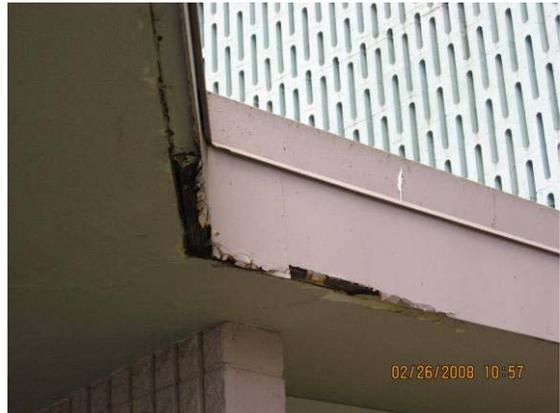
Photo 1: 1028

Building ID: bldg A
CommonAreaName: Lobby
CommonArealtem: Ceiling
Deficiency: corroded
Remedy: Replace
Description: flashing

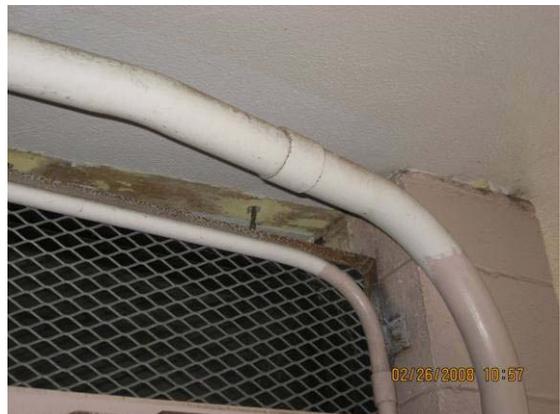
Photo 1: 1029

Building ID: bldg A
CommonAreaName: Lobby
CommonArealtem: Ceiling
Deficiency: bulging/buckling/sagging
Remedy: Hire Consultant
Description: show sign of shifting

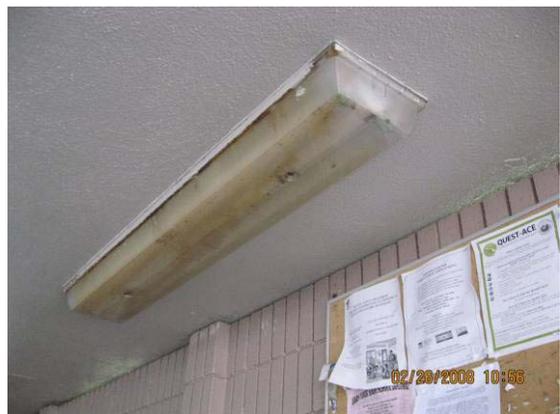
Photo 1: 1027

Building ID: bldg A
CommonAreaName: Lobby
CommonArealtem: Lighting
Deficiency: inadequate
Remedy: Replace
Description: install - provide more lighting

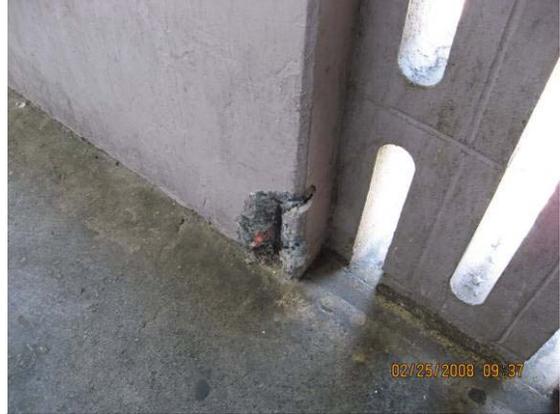
Photo 1: 925

Building ID: bldg A
CommonAreaName: Lobby
CommonArealtem: Walls
Deficiency: Other (Description)
Remedy: Hire Consultant
Description: 16th floor-exposed rebars

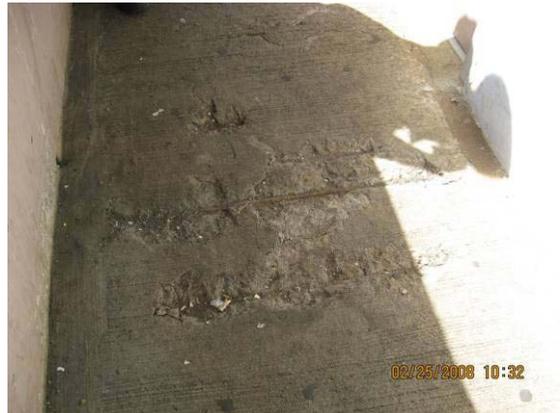
Photo 1: 941

Building ID: bldg A
CommonAreaName: Corridor
CommonArealtem: Floors/Floor Covering
Deficiency: excessively weathered
Remedy: Fill/Patch
Description: 15th floor-exposed re bar

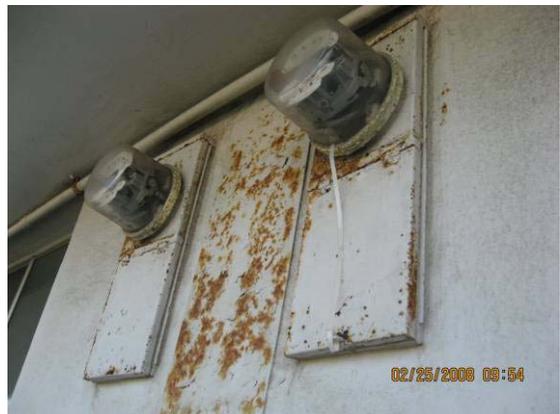
Photo 1: 929

Building ID: bldg A
CommonAreaName: Corridor
CommonArealtem: Other (Description)
Deficiency: corroded
Remedy: Replace
Description: elect meter-corroded casing, exposed to elements-safety hazard

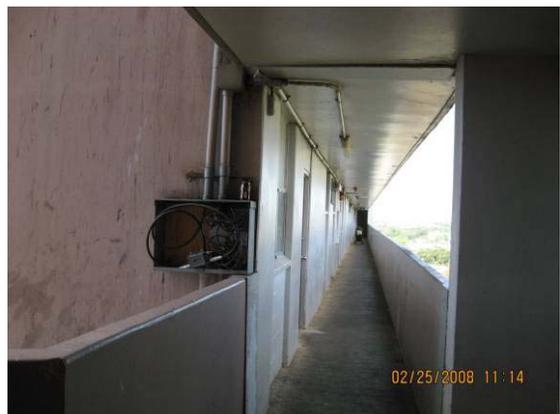
Photo 1: 949

Building ID: bldg A
CommonAreaName: Corridor
CommonArealtem: Other (Description)
Deficiency: damaged
Remedy: Replace
Description: 12th floor (elect panel - cover)

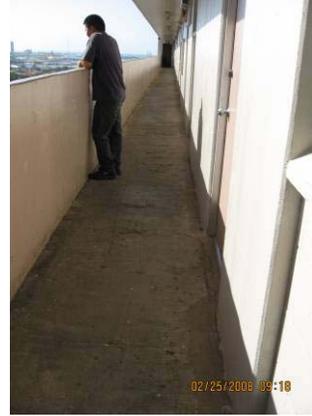
Building ID: bldg A
CommonAreaName: Corridor
CommonArealtem: Other (Description)
Deficiency: Other (Description)
Remedy: Clean/Deodorize
Description: WALLS-prep/paint, CONC RAILING-cracked, chipping, steel connector-corroded
Photo 1: 921

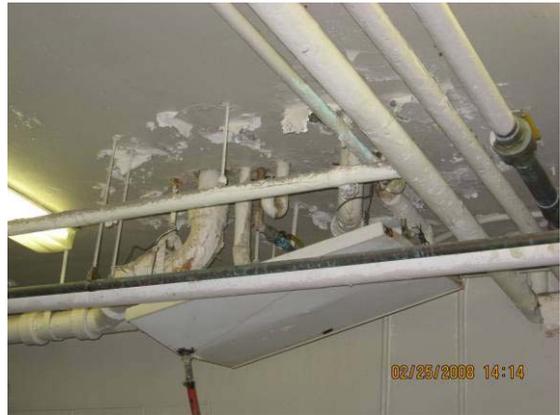
Building ID: bldg A
CommonAreaName: Laundry
CommonArealtem: Ceiling
Deficiency: paint peeled
Remedy: Prep/Repaint
Description: LAUNDRY- dr, frame -repaint, pipes expose-safety hazard ducts exposed(washer?-need)
Photo 1: 973

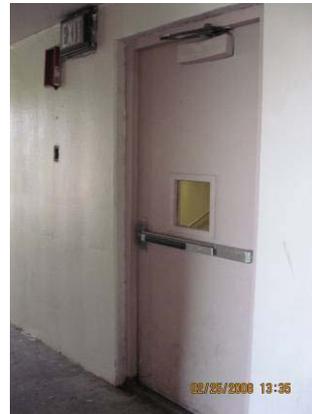
Building ID: bldg A
CommonAreaName: Stairs
CommonArealtem: Doors
Deficiency: damaged
Remedy: Replace
Description: 4th floor-dr hardware, closer, frame-corroded
Photo 1: 959

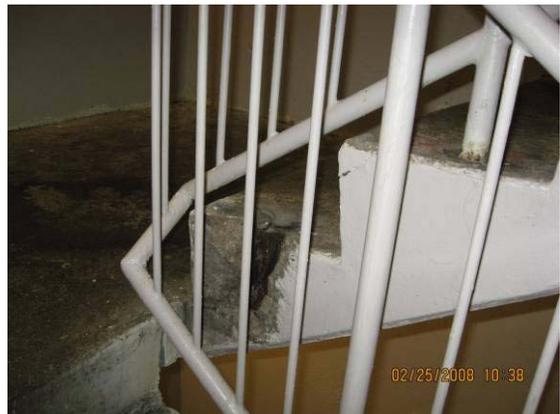
Building ID: bldg A
CommonAreaName: Stairs
CommonArealtem: Floors/Floor Covering
Deficiency: cracked/gaps
Remedy: Fill/Patch
Description: 15th/14th-exposed rebar-@ tread/risers
Photo 1: 943

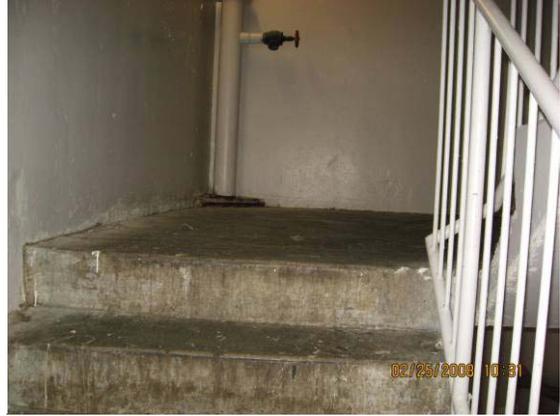
Photo 1: 940

Building ID: bldg A
CommonAreaName: Stairs
CommonArealetem: Other (Description)
Deficiency: cracked/gaps
Remedy: Repair
Description: dry standpipe base-corroded

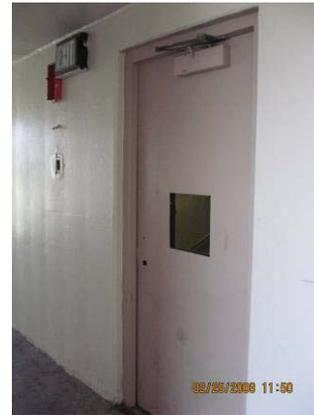
Photo 1: 955

Building ID: bldg A
CommonAreaName: Stairs
CommonArealetem: Other (Description)
Deficiency: excessively weathered
Remedy: Repair
Description: dr-replace, closer, dr hardware, vision panel

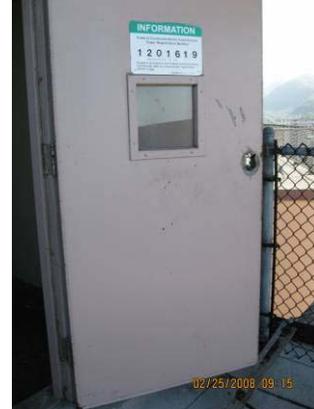
Photo 1: 918

Building ID: bldg A
CommonAreaName: Stairs
CommonArealetem: Other (Description)
Deficiency: Other (Description)
Remedy: Replace
Description: 17th fl-dr hardware, hinges, vision safety glass, dr closer

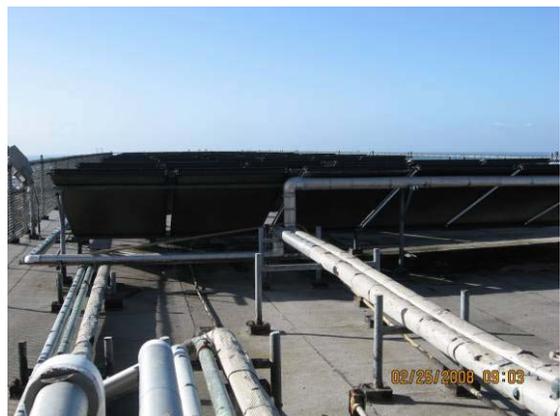
Building ID: bldg A
CommonAreaName: Other (Description)
CommonArealetem:
Deficiency:
Remedy: Replace
Description: 3-WING ROOF-water ponding, duct system, base flashing, exhaust fan, weeds growing, 905

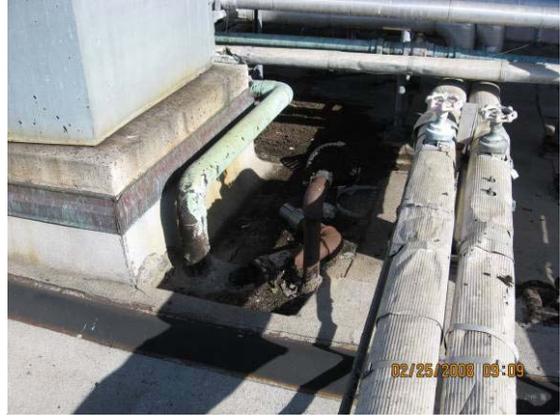
Photo 1: 910

Building ID: bldg A
CommonAreaName: Other (Description)
CommonArealtem:
Deficiency: Other (Description)
Remedy: Replace
Description: 3 WING ROOF

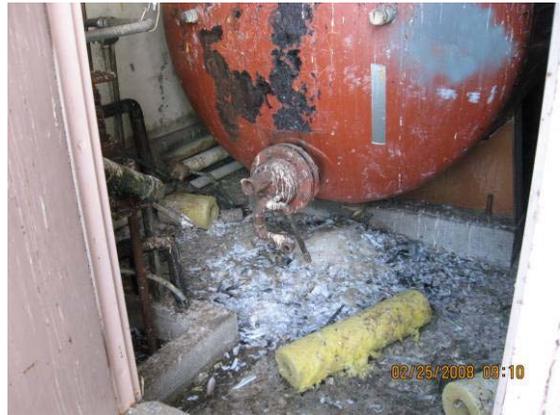
Photo 1: 911

Building ID: bldg A
CommonAreaName: Other (Description)
CommonArealtem:
Deficiency: damaged
Remedy: Replace
Description: STORAGE TANK @ ROOF
tank-non operational, walls,
floor, ceiling-re-DO

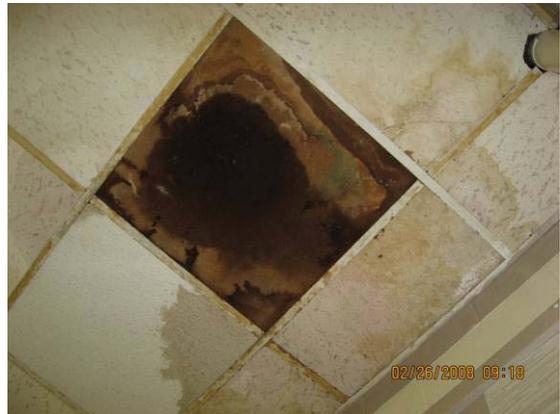
Photo 1: 996

Building ID: bldg A
CommonAreaName: Other (Description)
CommonArealtem: Ceiling
Deficiency: water stained/damaged
Remedy: Replace
Description: @ office -cIng 20%(leaking)

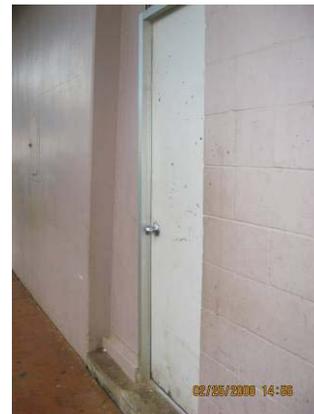
Photo 1: 993

Building ID: bldg A
CommonAreaName: Other (Description)
CommonArealtem: Doors
Deficiency: Other (Description)
Remedy: Replace
Description: HEALTH CENTER-inadequate dr
width, prep/repaint

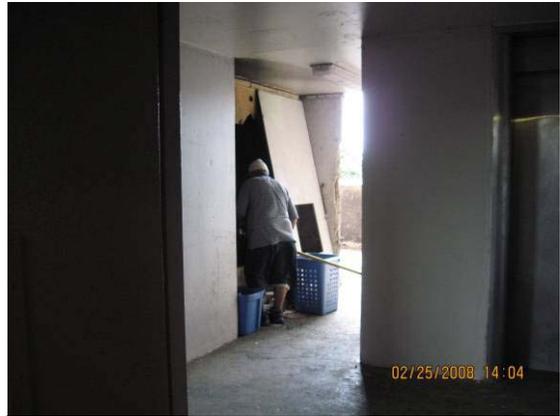
Building ID: bldg A
CommonAreaName: Other (Description)
CommonArealtem: Trash Chute
Deficiency: Other (Description)
Remedy: Repair
Description: 2nd floor-replace wall, door, hardware-prep and repaint. Floor clean, sanitize & reseal
Photo 1: 964

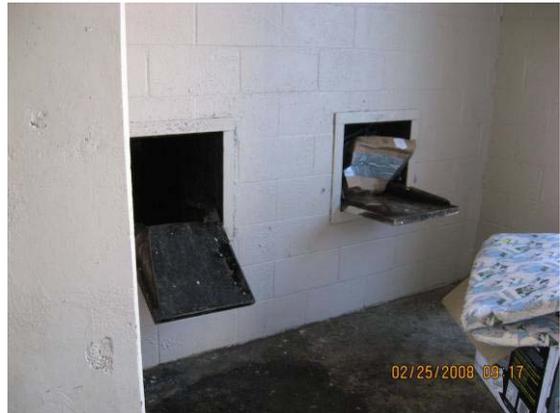
Building ID: bldg A
CommonAreaName: Other (Description)
CommonArealtem: Trash Chute
Deficiency: corroded
Remedy: Replace
Description: TC - total replacement, walls-patch & repair, prep, paint, floors-clean, sanitize
Photo 1: 920

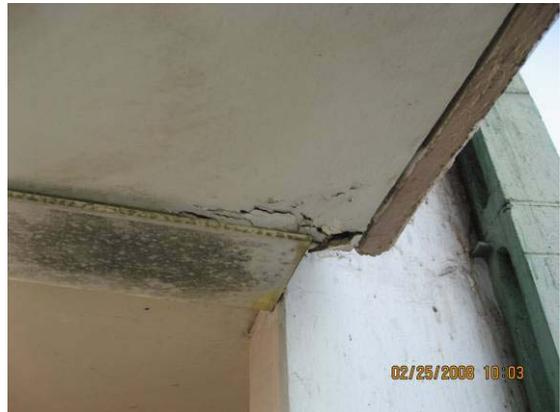
Building ID: bldg A
CommonAreaName: Other (Description)
CommonArealtem: Other (Description)
Deficiency: spalled
Remedy: Repair
Description: 16th floor-expansion joint @ ceiling, exp jt cover-corroded, elect panel-rust, damaged
Photo 1: 930

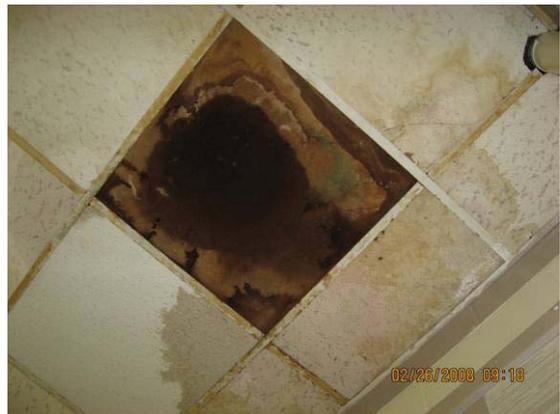
Building ID: bldg A
CommonAreaName: Other (Description)
CommonArealtem: Other (Description)
Deficiency: Other (Description)
Remedy: Other (Description)
Description: KPT Office-replace ACTiles - 20%(water damages, leak) FLOOR-Replace. Lighting-
Photo 1: 996

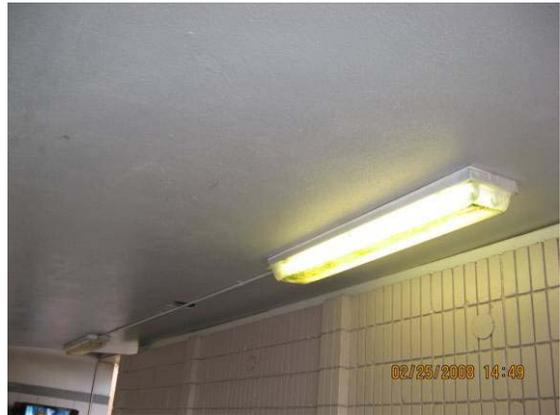
Photo 1: 992

Building ID: bldg B
CommonAreaName: Lobby
CommonArealtem: Ceiling
Deficiency: rotted
Remedy: Repair
Description: Gr Floor- patch hole
Wall-prep/paint
Floor-prep/clean/sanitize

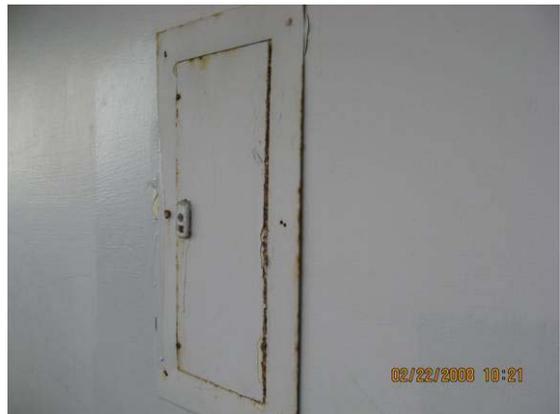
Photo 1: 870

Building ID: bldg B
CommonAreaName: Corridor
CommonArealtem: Receptacles/Switches
Deficiency: corroded
Remedy: Replace
Description: 16th floor-dr, frame corroded

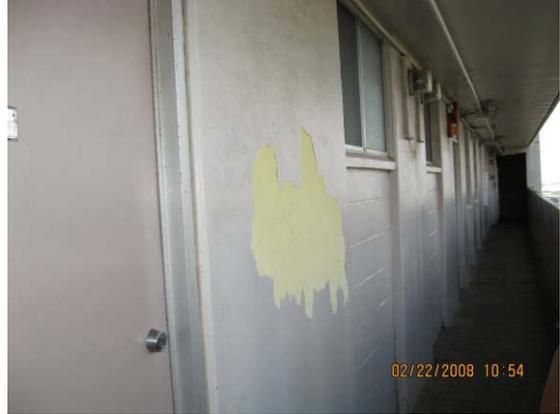
Building ID: bldg B
CommonAreaName: Corridor
CommonArealtem: Walls
Deficiency: cracked/gaps
Remedy: Repair
Description: 14th floor-floor-patch/refinish & clean railing patch & fill
Photo 1: 876

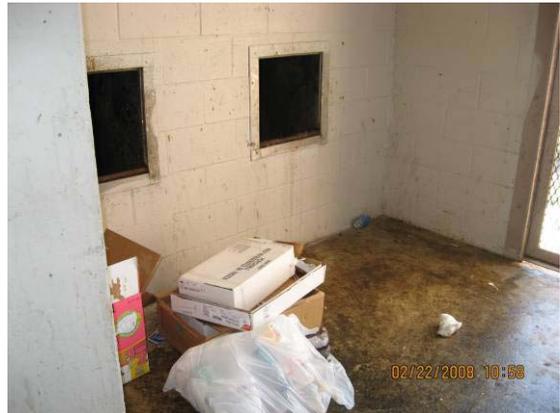
Building ID: bldg B
CommonAreaName: Refuse Room
CommonArealtem: Trash Chute
Deficiency: damaged
Remedy: Repair
Description: 12th floor-floor - refinished, door-replaced, walls-prep/repaint. Excess trash @ all floors
Photo 1: 877

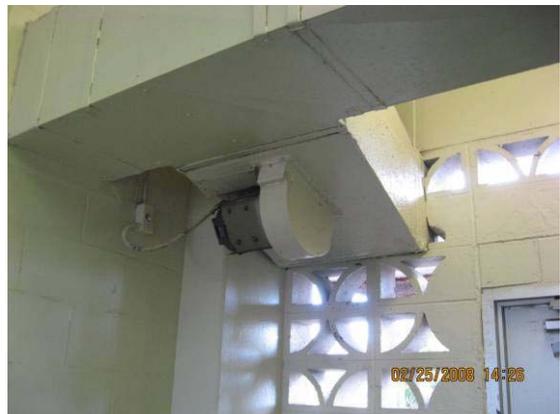
Building ID: bldg B
CommonAreaName: Laundry
CommonArealtem: HVAC
Deficiency: inoperable
Remedy: Replace
Description: exhaust vent, hazard, door, frame, hardware-replace
Photo 1: 981

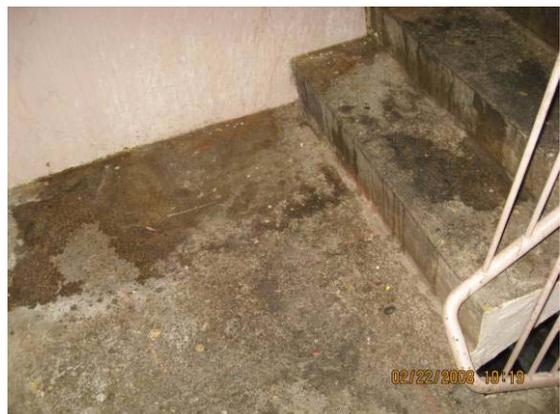
Building ID: bldg B
CommonAreaName: Stairs
CommonArealtem: Floors/Floor Covering
Deficiency: excessively weathered
Remedy: Repair
Description: treads/risers - re fnish, walls prep/repaint, railing refinish. Clean & sanitized
Photo 1: 869

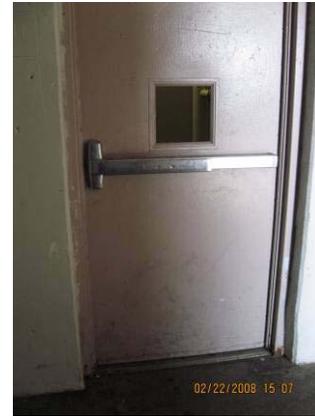
Photo 1: 903

Building ID: bldg B
CommonAreaName: Stairs
CommonArealtem: Other (Description)
Deficiency: corroded
Remedy: Replace
Description: 2nd floor-dr, frame-corroded

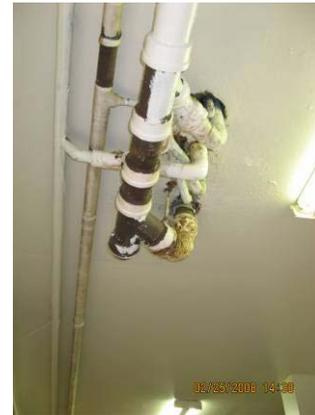
Photo 1: 988

Building ID: bldg B
CommonAreaName: Other (Description)
CommonArealtem: Ceiling
Deficiency: leaking
Remedy: Replace
Description: Office(kokua)-pipes corroded
Door, frame-repaint
Walls-prep/paint

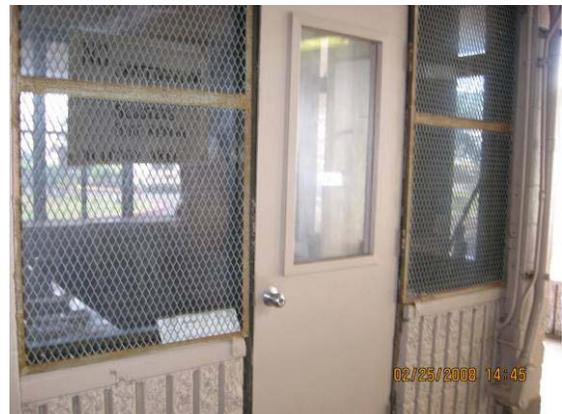
Photo 1: 990

Building ID: bldg B
CommonAreaName: Other (Description)
CommonArealtem: Ceiling
Deficiency: water stained/damaged
Remedy: Prep/Repaint
Description: Security room-floor clean/replace
Wall-prep/paint
Wdw-prep/repair(expanded wire)

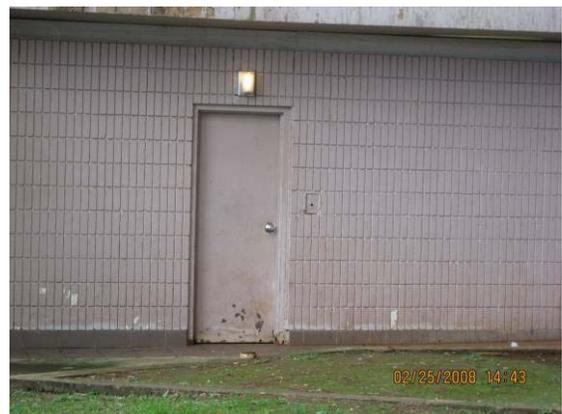
Photo 1: 989

Building ID: bldg B
CommonAreaName: Other (Description)
CommonArealtem: Doors
Deficiency: excessively weathered
Remedy: Replace
Description: Mail room-Floors refinish
Wall-prep/paint
Ceiling-prep/paint

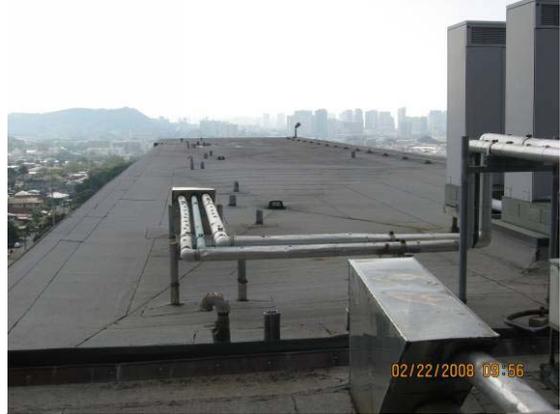
Building ID: bldg B
CommonAreaName: Other (Description)
CommonArealtem: Other (Description)
Deficiency: excessively weathered
Remedy: Replace
Description: Roof-3 wing-roof, drains, exhaust & steel support corroded
Photo 1: 860

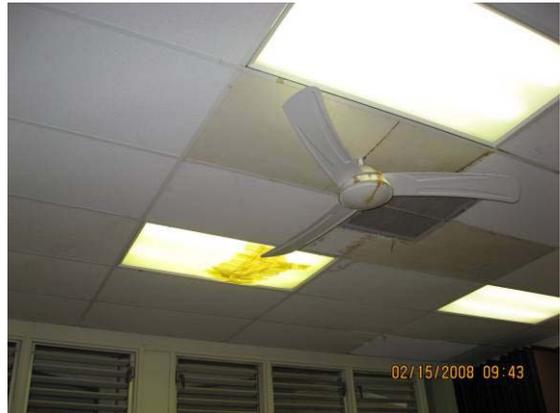
Building ID: Comm bldg
CommonAreaName: Community Room
CommonArealtem: Ceiling
Deficiency: broken
Remedy: Replace
Description: Main Hall-replace 10%(act)
Wall-prep/paint
Floor-replace
Photo 1: 749

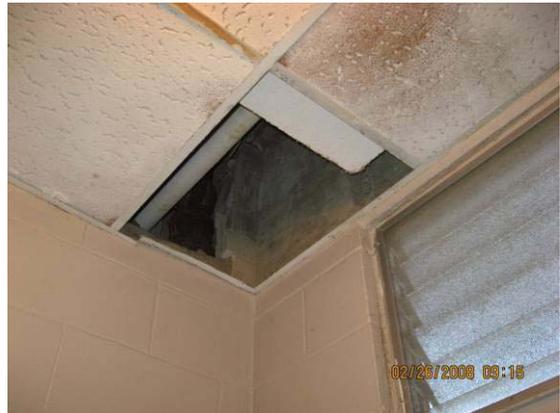
Building ID: bldg A
CommonAreaName: Restrooms
CommonArealtem: Ceiling
Deficiency: water stained/damaged
Remedy: Replace
Description: KPT- toilets, Walls-replaced(wainscot), prep and paint all 4 sides. Faucet-replace
Photo 1: 995

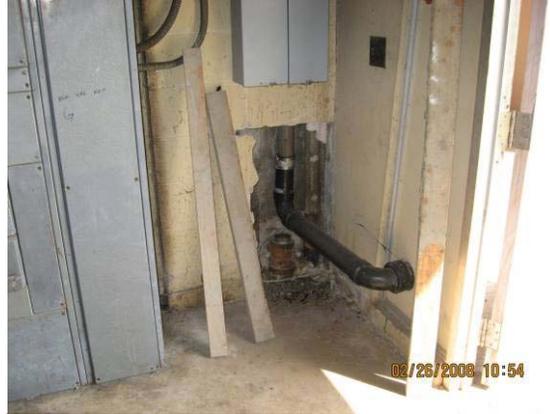
Photo 1: 1024

Building ID: bldg A
CommonAreaName: Electrical Rooms
CommonAreatem: Walls
Deficiency: paint faded
Remedy: Prep/Repaint
Description:

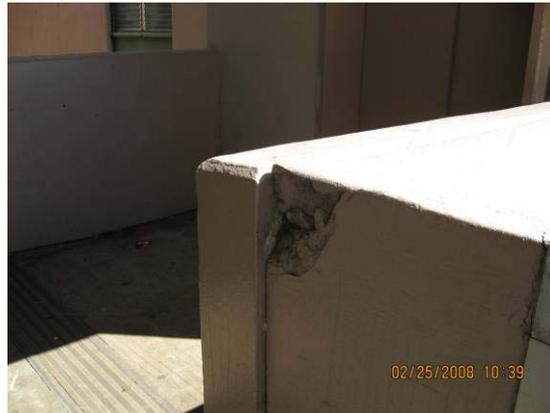
Photo 1: 944

Building ID: bldg A
CommonAreaName: Corridor
CommonAreatem: Handrails/Guardrails
Deficiency: spalled
Remedy: Repair
Description: 14th floor(typ on all corridors)

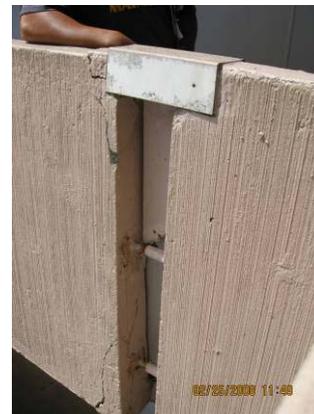
Photo 1: 954

Building ID: bldg A
CommonAreaName: Corridor
CommonAreatem: Handrails/Guardrails
Deficiency: corroded
Remedy: Replace
Description: 9th floor-expansion jt, railing-repair

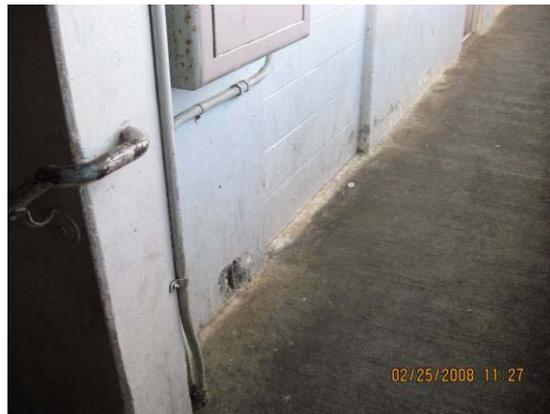
Photo 1: 952

Building ID: bldg A
CommonAreaName: Stairs
CommonAreatem: Walls
Deficiency: excessively weathered
Remedy: Repair
Description: 11th floor-exposed rebar(@ unit 1118)

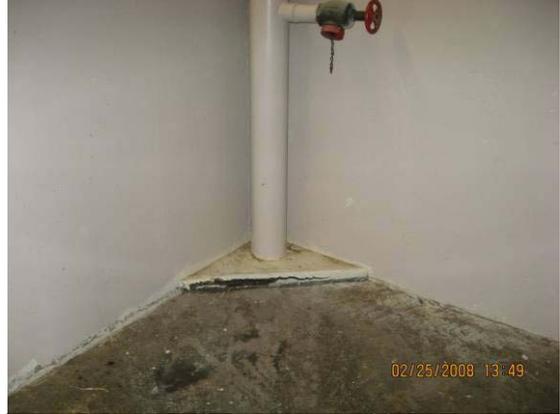
Building ID: bldg A
CommonAreaName: Stairs
CommonArealtem: Other (Description)
Deficiency: cracked/gaps
Remedy: Repair
Description: 3rd floor-base- spalled, (overall-stairs)foul odor-human feces, urine
Photo 1: 963

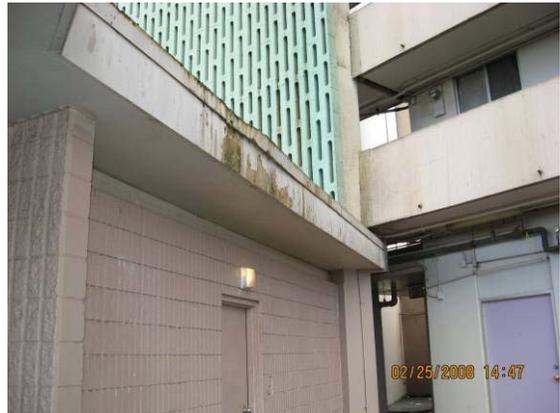
Building ID: bldg A
CommonAreaName: Other (Description)
CommonArealtem: Doors
Deficiency: corroded
Remedy: Replace
Description: Mailroom-walls prep/paint, ceiling prep/paint, floor replace
Photo 1: 991

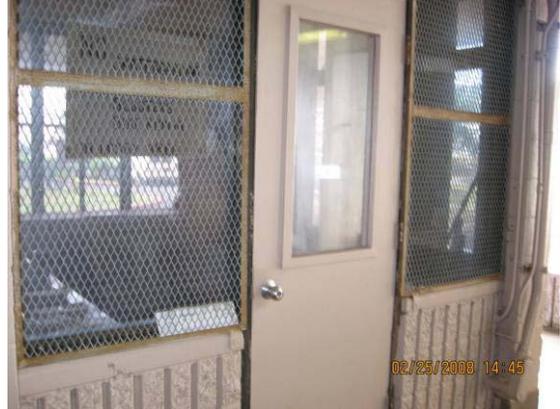
Building ID: bldg A
CommonAreaName: Other (Description)
CommonArealtem: Walls
Deficiency: paint faded
Remedy: Prep/Repaint
Description: Security Office-replace door, windows-reinstall security screen mesh
Photo 1: 990

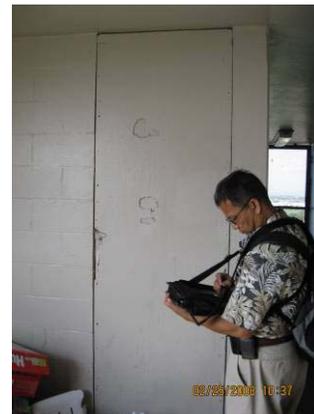
Building ID: bldg A
CommonAreaName: Other (Description)
CommonArealtem: Walls
Deficiency: damaged
Remedy: Fill/Patch
Description: JAN ROOM 15th floor-
Photo 1: 942

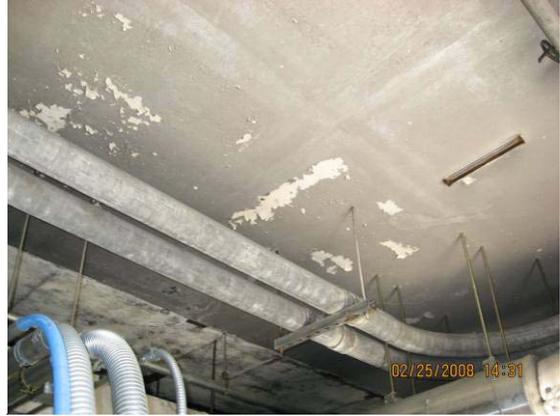
Building ID: bldg B
CommonAreaName: Electrical Rooms
CommonArealtem: Ceiling
Deficiency: water stained/damaged
Remedy: Replace
Description: Door, frames & louver-corroded
Walls-prep/paint
Floor-clean, prep/sanitize/fill
Photo 1: 985

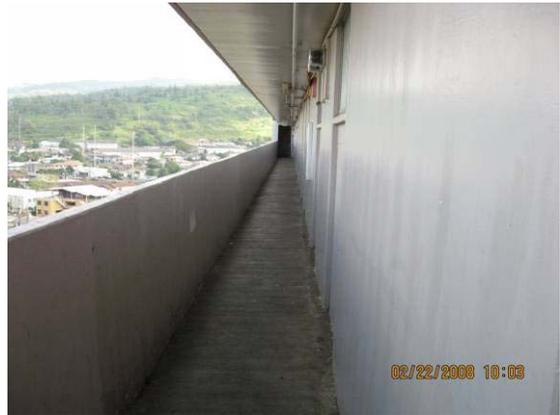
Building ID: bldg B
CommonAreaName: Corridor
CommonArealtem: Floors/Floor Covering
Deficiency: cracked/gaps
Remedy: Repair
Description: Walls, conc railing -prep/paint
Photo 1: 866

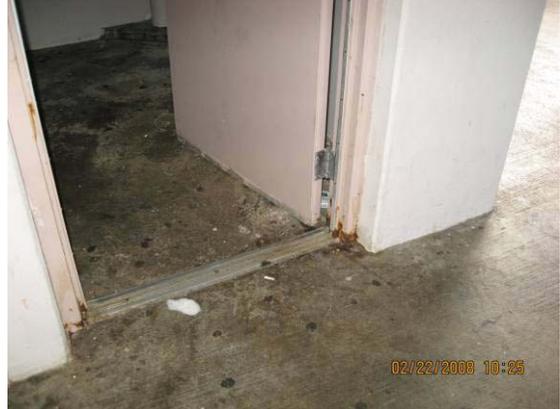
Building ID: bldg B
CommonAreaName: Corridor
CommonArealtem: Handrails/Guardrails
Deficiency: cracked/gaps
Remedy: Repair
Description: 15th floor-floor excessive
weatherd, railing cracked,
corroded
Photo 1: 871

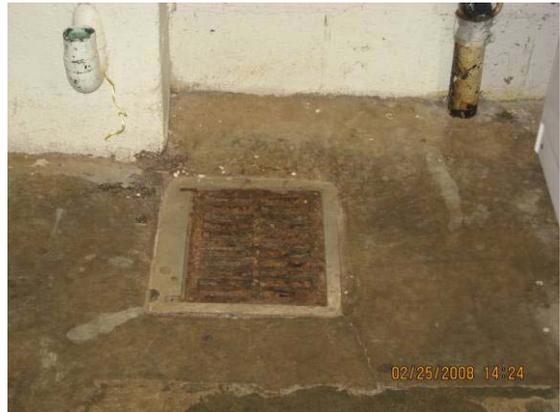
Building ID: bldg B
CommonAreaName: Laundry
CommonArealtem: Floors/Floor Covering
Deficiency: Other (Description)
Remedy: Replace
Description: fl drain-replace, corroded.
Inadequar w. machine, cctv in
operable.
Photo 1: 978

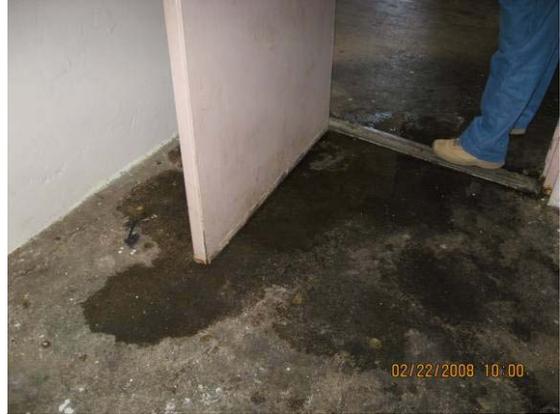
Photo 1: 865

Building ID: bldg B
CommonAreaName: Stairs
CommonArealtem: Other (Description)
Deficiency: leaking
Remedy: Repair
Description: 17th floor-door, frame-corroded

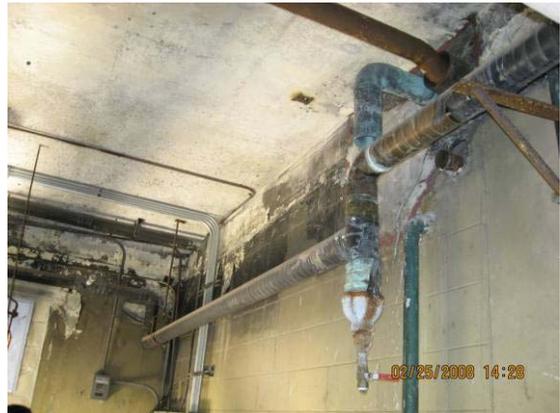
Photo 1: 984

Building ID: bldg B
CommonAreaName: Other (Description)
CommonArealtem: Ceiling
Deficiency: water stained/damaged
Remedy: Repair
Description: Boiler rm- Walls clean, prep/paint
Pipes-corroded
Floor -water stain

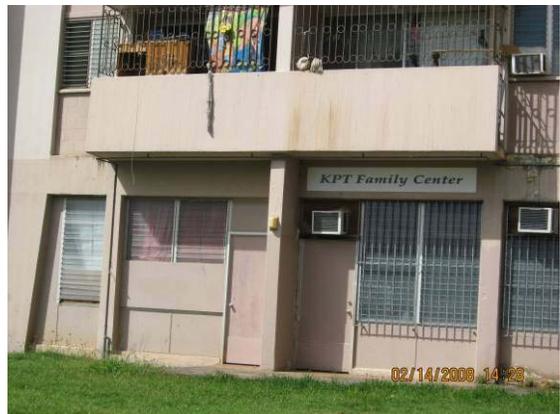
Photo 1: 662

Building ID: bldg B
CommonAreaName: Other (Description)
CommonArealtem: Doors
Deficiency: paint faded
Remedy: Prep/Repaint
Description: KPT Family Ctr-
Ceiling-prep/paint
Wall-prep/paint

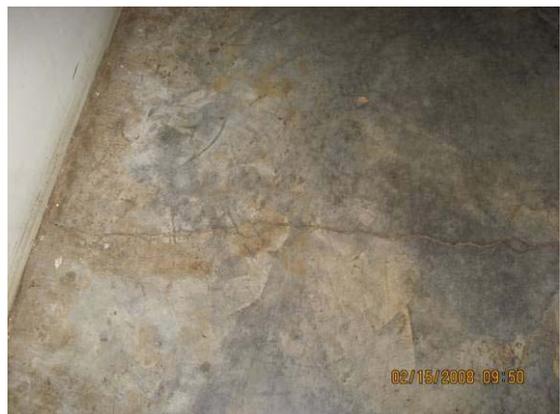
Photo 1: 758

Building ID: Comm bldg
CommonAreaName: Community Room
CommonArealtem: Floors/Floor Covering
Deficiency: cracked/gaps
Remedy: Fill/Patch
Description: @ Community room hallway-floor
Ceiling-prep/repaint

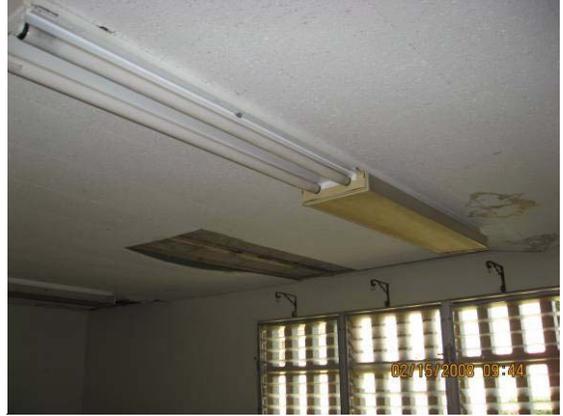
Building ID: Comm bldg
CommonAreaName: Other (Description)
CommonAreaItem: Ceiling
Deficiency: water stained/damaged
Remedy: Straighten
Description: @Community room-
OFFICE/LOUNGE
Lighting-replace
Photo 1: 750

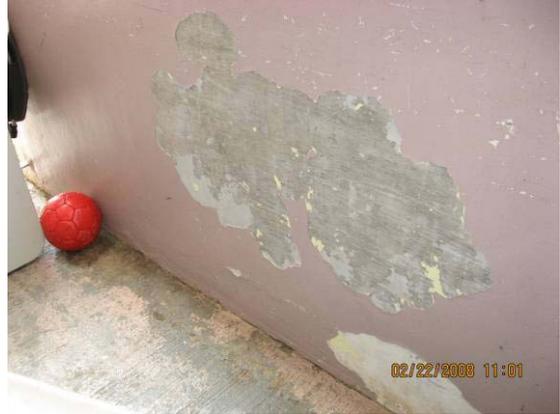
Photo 1: 879

Entry Item Name: Walls
Deficiency: paint peeled
Remedy:
Description:

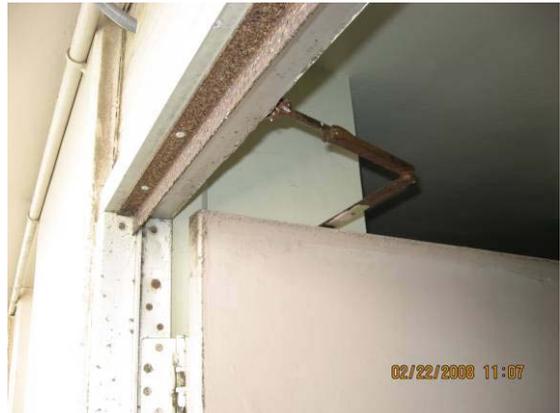
Entry Item Name: Door
Deficiency: Other (Description)
Remedy: Other (Description)
Description: Frame rust, refinish, door closer-
replace

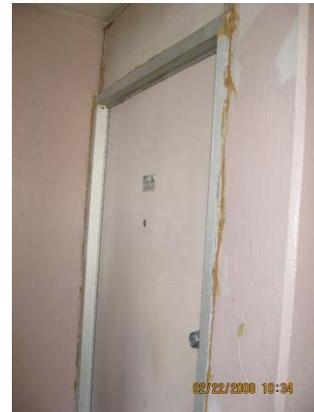
Photo 1: 874

Entry Item Name: Door
Deficiency: paint peeled
Remedy: Prep/Repaint
Description:

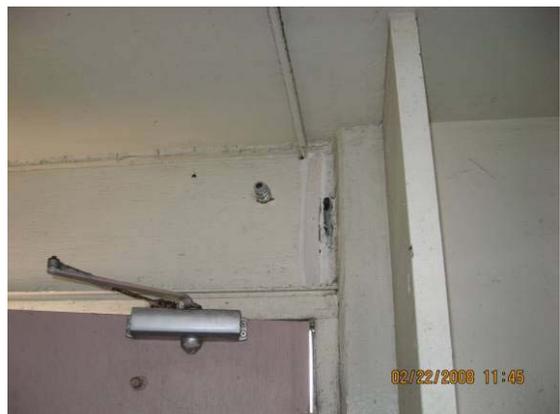
Photo 1: 890

Entry Item Name: Door
Deficiency: Other (Description)
Remedy: Repair
Description: No sign, threshold, dr hardware

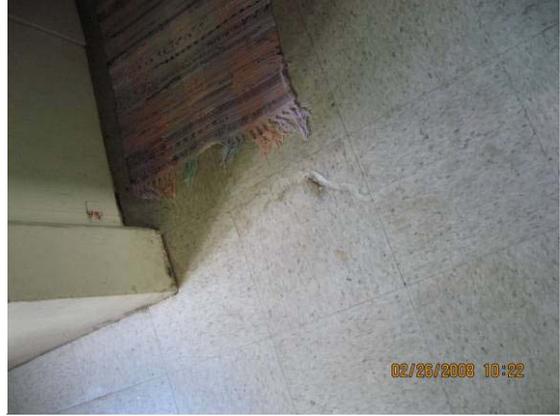
Building ID: bldg C **UnitID:** 1566
Living/Dining Item Name: Floor Covering
Deficiency: damaged
Remedy: Install
Description: replace, repair
Photo 1: 1004

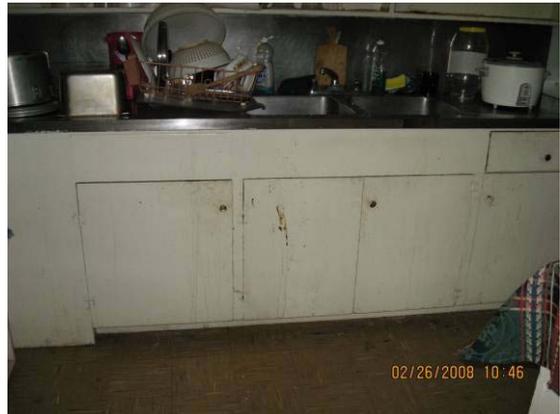
Building ID: bldg D **UnitID:** 1532
Kitchen Item Name: Cabinets
Deficiency: Other (Description)
Remedy: Install
Description: cab not ada, lite lens,
Photo 1: 1020

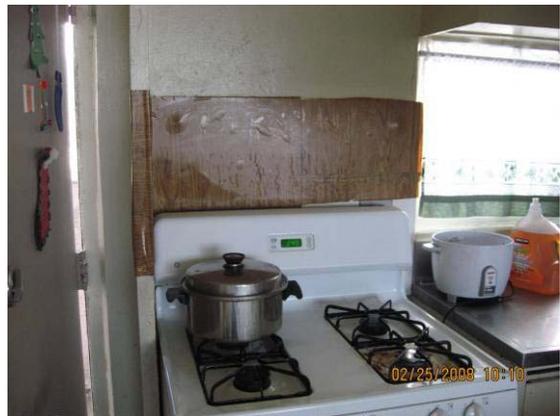
Building ID: bldg A **UnitID:** 1611
Kitchen Item Name: Walls
Deficiency: paint peeled
Remedy: Prep/Repaint
Description:
Photo 1: 933

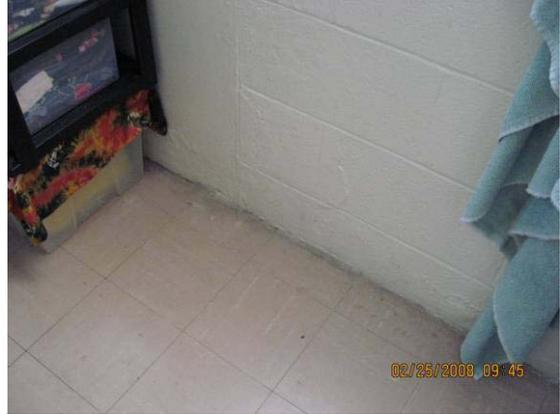
Photo 1: 927

Building ID: bldg A **UnitID:** 1618 **Bedroom Number:** 3
Bedroom Item Name: Floor Covering
Deficiency: leaking
Remedy: Repair
Description:

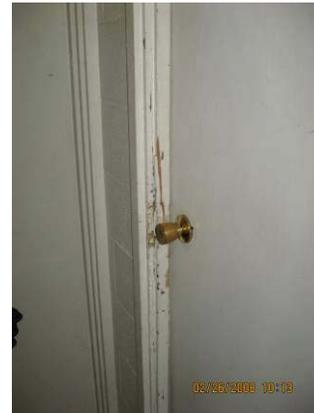
Photo 1: 1002

Building ID: bldg C **UnitID:** 1558 **Bedroom Number:** 4
Bedroom Item Name: Door
Deficiency: Other (Description)
Remedy: Repair
Description: dr, frame-paint

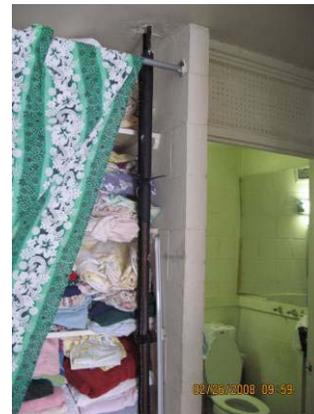
Photo 1: 997

Building ID: bldg C **UnitID:** 1488
Closet Item Name: Other (Description)
Deficiency: Other (Description)
Remedy: Replace
Description: re insulate pipes(hall)

Immediate
