2008 Physical Needs Assessment and Energy Audit For Federally Assisted Projects

Kuhio Park Terrace

HPHA Project Number HIOP001010

Honolulu Oahu

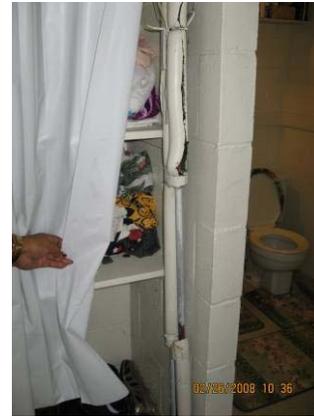
Photo 1: 1017

Deficiency: damaged

Description: re-insulate

Remedy: Replace

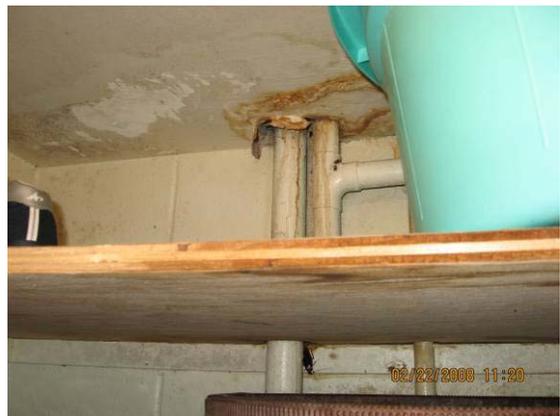
Photo 1: 883

Building ID: bldgB **UnitID:** 1210

Closet Item Name: Other (Description)

Deficiency: leaking

Description: Leaking-ceiling,

Urgent

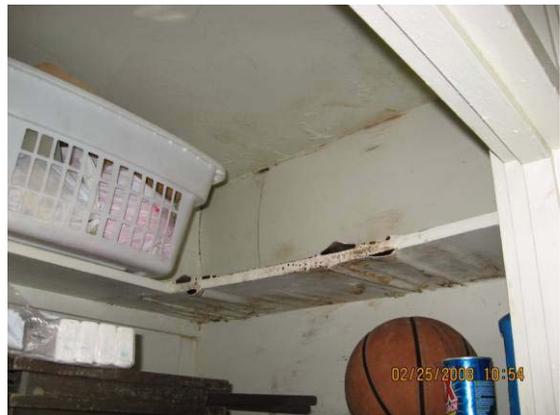
Photo 1: 946

Deficiency: leaking

Description: wall, shelves

Urgent

Remedy: Repair

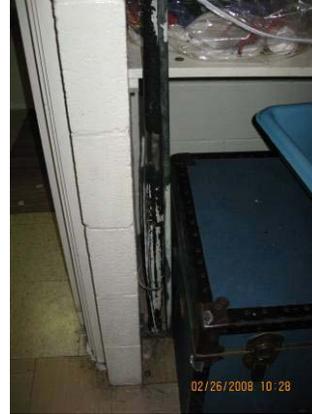
Building ID: bldg C **UnitID:** 1566
Closet Item Name: Other (Description)
Deficiency: damaged
Remedy: Replace
Description: insulate piping/ reseal pipes-clng & floor
Photo 1: 1010

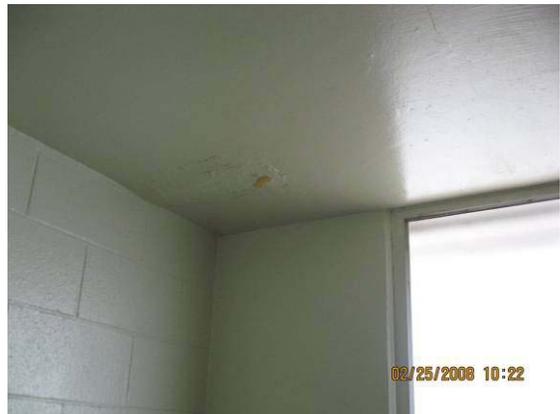
Building ID: bldg A **Unit ID:** 1602 **Bathroom Number:**
Bathroom Item Name: Ceiling
Deficiency: leaking
Remedy: Repair
Description:
Photo 1: 936

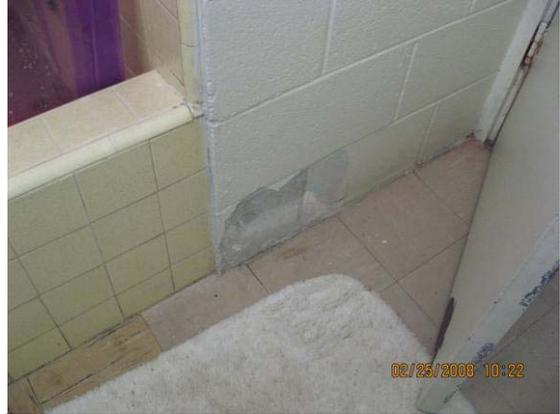
Photo 1: 938

Building ID: bldg A **Unit ID:** 1602 **Bathroom Number:**
Bathroom Item Name: Walls
Deficiency: paint peeled
Remedy: Prep/Repaint
Description:

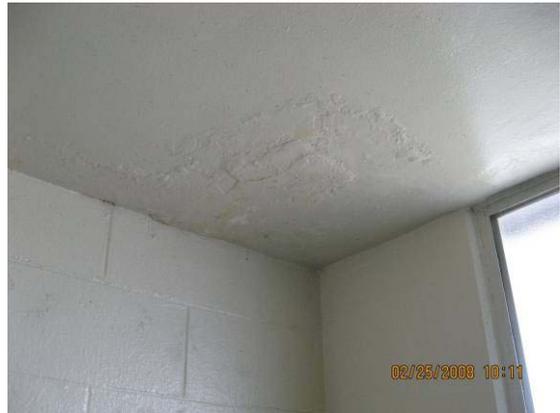
Photo 1: 934

Building ID: bldg A **Unit ID:** 1611 **Bathroom Number:**
Bathroom Item Name: Ceiling
Deficiency: leaking
Remedy: Repair
Description:

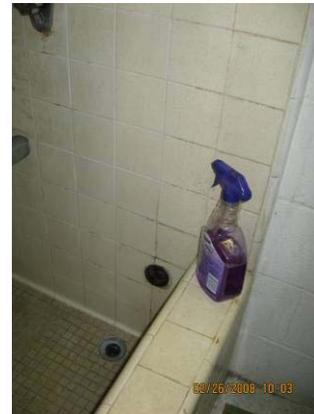
Photo 1: 999

Building ID: bldg C **Unit ID:** 1488 **Bathroom Number:**
Bathroom Item Name: Other (Description)
Deficiency: hole(s)
Remedy: Fill/Patch
Description: shower wall

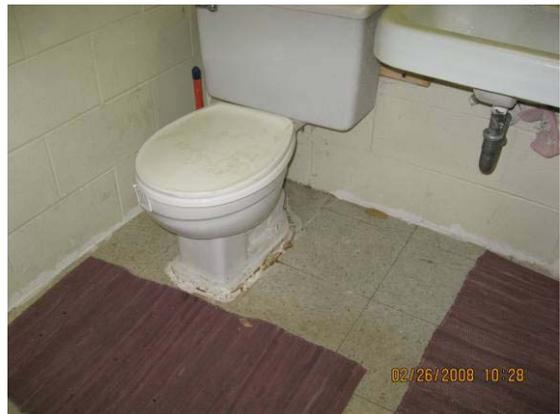
Photo 1: 1009

Building ID: bldg C **Unit ID:** 1566 **Bathroom Number:**
Bathroom Item Name: Toilet
Deficiency: Other (Description)
Remedy: Install
Description: re install, seal & renish

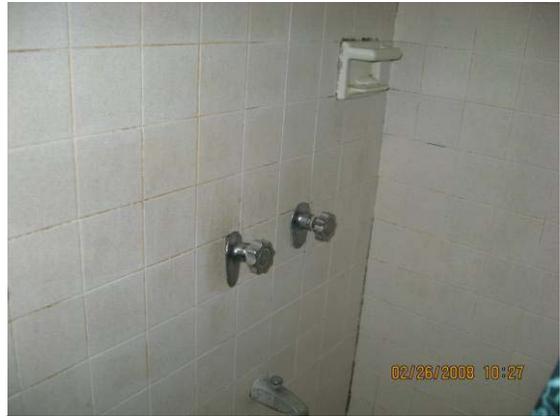
Photo 1: 1008

Building ID: bldg C **Unit ID:** 1566 **Bathroom Number:**
Bathroom Item Name: **Other (Description)**
Deficiency: leaking
Remedy: Replace
Description: shower fixtures

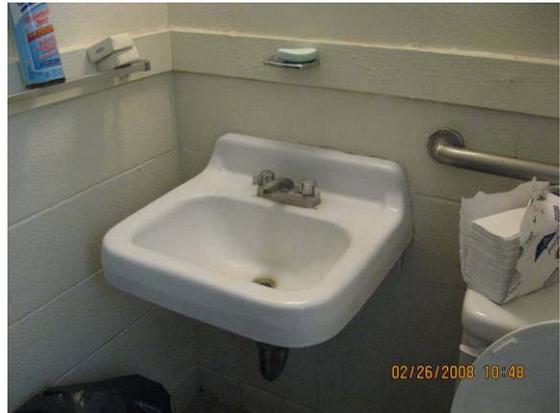
Photo 1: 1022

Building ID: bldg D **Unit ID:** 1532 **Bathroom Number:**
Bathroom Item Name: **Other (Description)**
Deficiency: **Other (Description)**
Remedy: Replace
Description: lav to conform ada

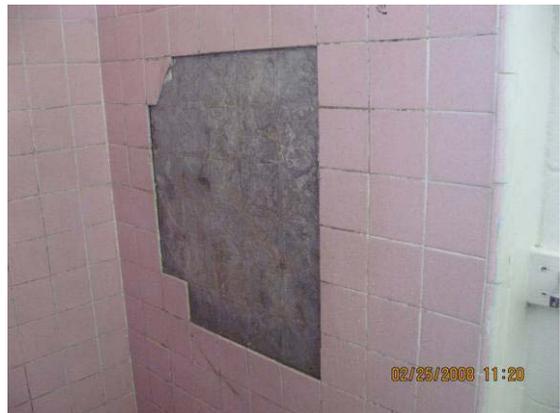
Photo 1: 950

Building ID: bldg A **Unit ID:** 1205 **Bathroom Number:**
Bathroom Item Name: **Tub/Surround**
Deficiency:
Remedy: Install
Description: tiles missing

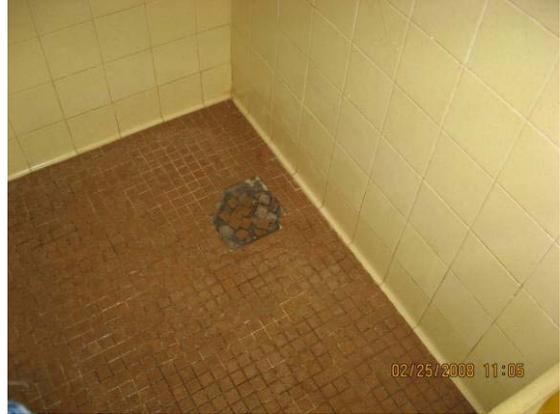
Photo 1: 947

Building ID: bldg A **Unit ID:** 1218 **Bathroom Number:**
Bathroom Item Name: Tub/Surround
Deficiency: broken
Remedy: Repair
Description:

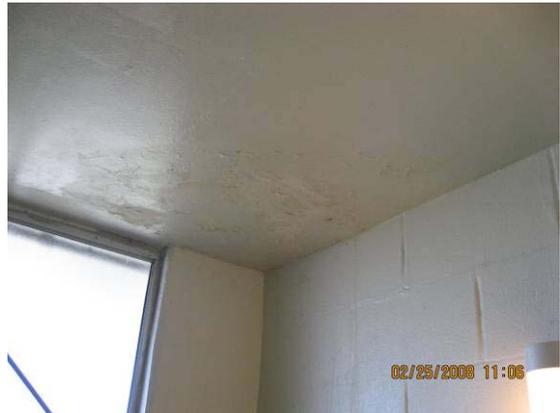
Photo 1: 948

Building ID: bldg A **Unit ID:** 1218 **Bathroom Number:**
Bathroom Item Name: Ceiling
Deficiency: leaking
Remedy: Repair
Description:

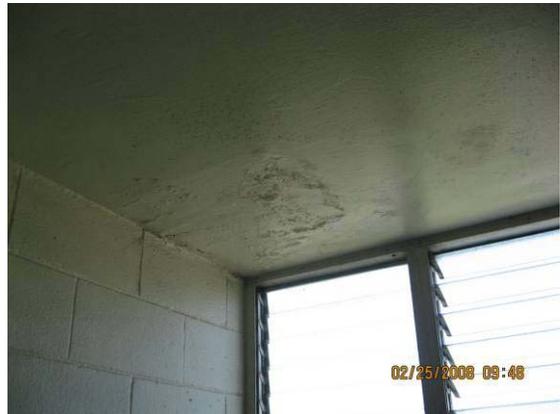
Photo 1: 928

Building ID: bldg A **Unit ID:** 1618 **Bathroom Number:**
Bathroom Item Name: Ceiling
Deficiency: paint peeled
Remedy: Prep/Repaint
Description:

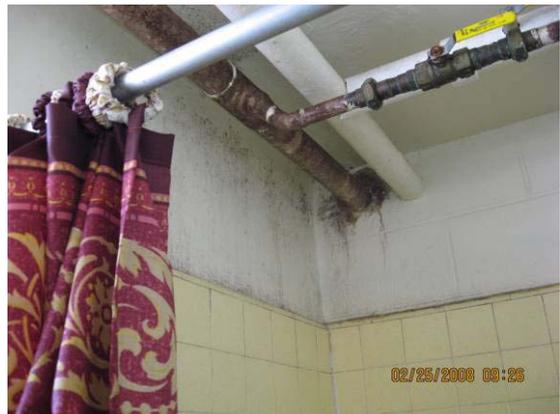
Photo 1: 923

Building ID: bldg A **Unit ID:** 1702 **Bathroom Number:**
Bathroom Item Name: Ceiling
Deficiency: mold/mildew
Remedy: Prep/Repaint
Description:

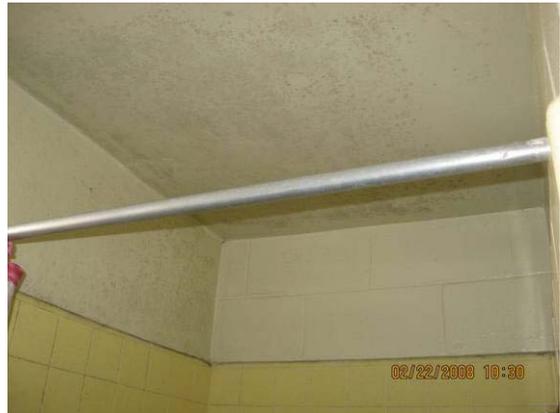
Photo 1: 872

Building ID: bldgB **Unit ID:** 1512 **Bathroom Number:**
Bathroom Item Name: Ceiling
Deficiency: mold/mildew
Remedy: Prep/Repaint
Description:

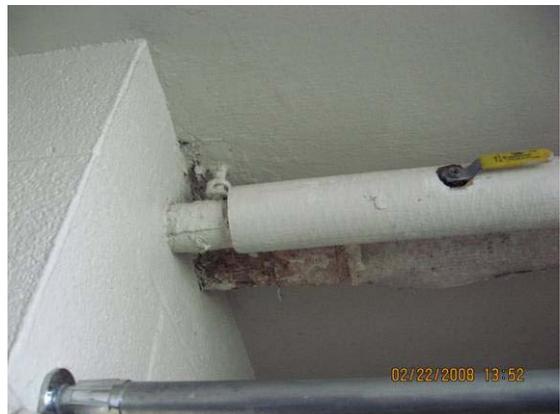
Photo 1: 892

Building ID: bldgB **Unit ID:** 805 **Bathroom Number:**
Bathroom Item Name: Ceiling
Deficiency: paint peeled
Remedy: Prep/Repaint
Description: pipes need insu

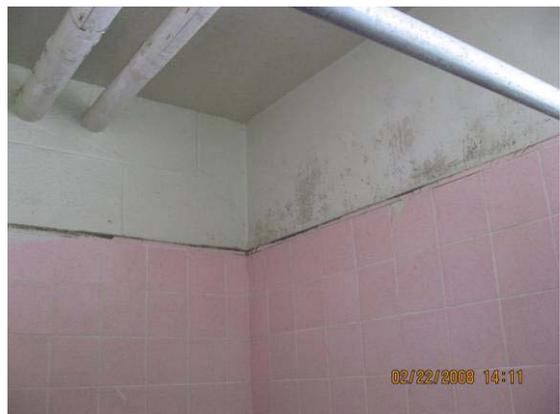
Photo 1: 896

Building ID: bldgB **Unit ID:** 816 **Bathroom Number:**
Bathroom Item Name: Ceiling
Deficiency: mold/mildew
Remedy: Treat
Description: Prep/paint

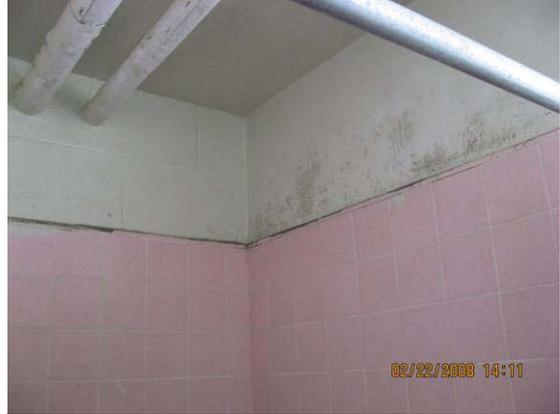
Photo 1: 896

Building ID: bldgB **Unit ID:** 816 **Bathroom Number:**
Bathroom Item Name: Walls
Deficiency: mold/mildew
Remedy: Regrade
Description: Tile wall, re-grout

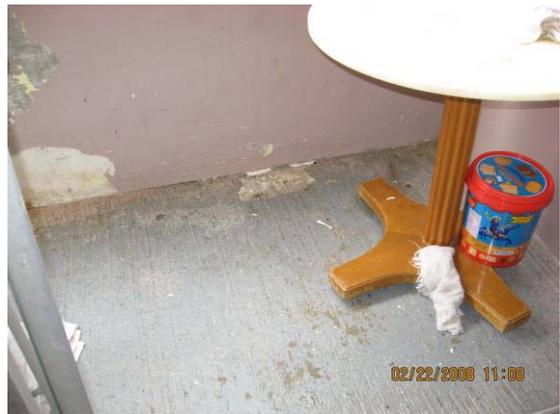
Photo 1: 878

Building ID: bldgB **UnitID:** 1201
Balcony Item Name: Floor Covering
Deficiency: Other (Description)
Remedy:
Description: rough

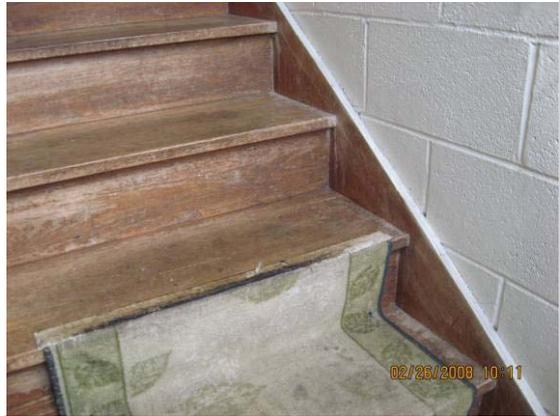
Photo 1: 1000

Deficiency: Other (Description)

Description: re finish, treads & riser

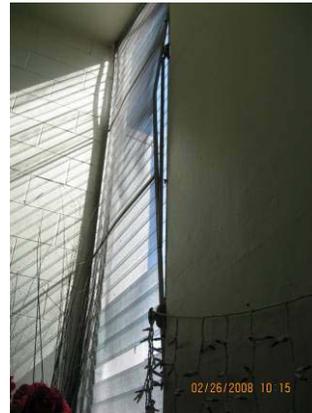
Photo 1: 1003

Building ID: bldg C **UnitID:** 1558

Stair Item Name: Window Screens

Deficiency: damaged

Description: wdw screen, hardware

Remedy: Replace

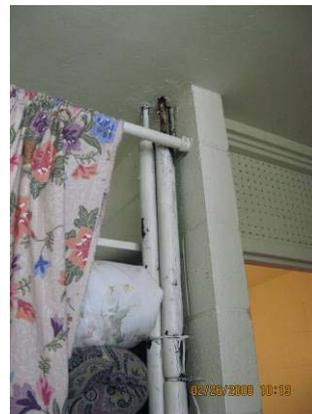
Photo 1: 1001

Deficiency: cracked/gaps

Description: replace insulation

Remedy: Replace

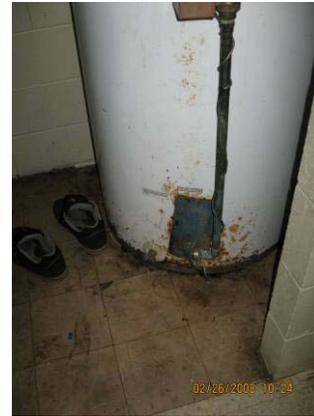
Photo 1: 1006

Deficiency: corroded

Description: w. htr-replace(

Remedy: Replace
